Melbourne Water Corporation

Area 4B of Riverwalk Estate, Princes Highway,
Werribee, Victoria

Environmental Audit

May 2014

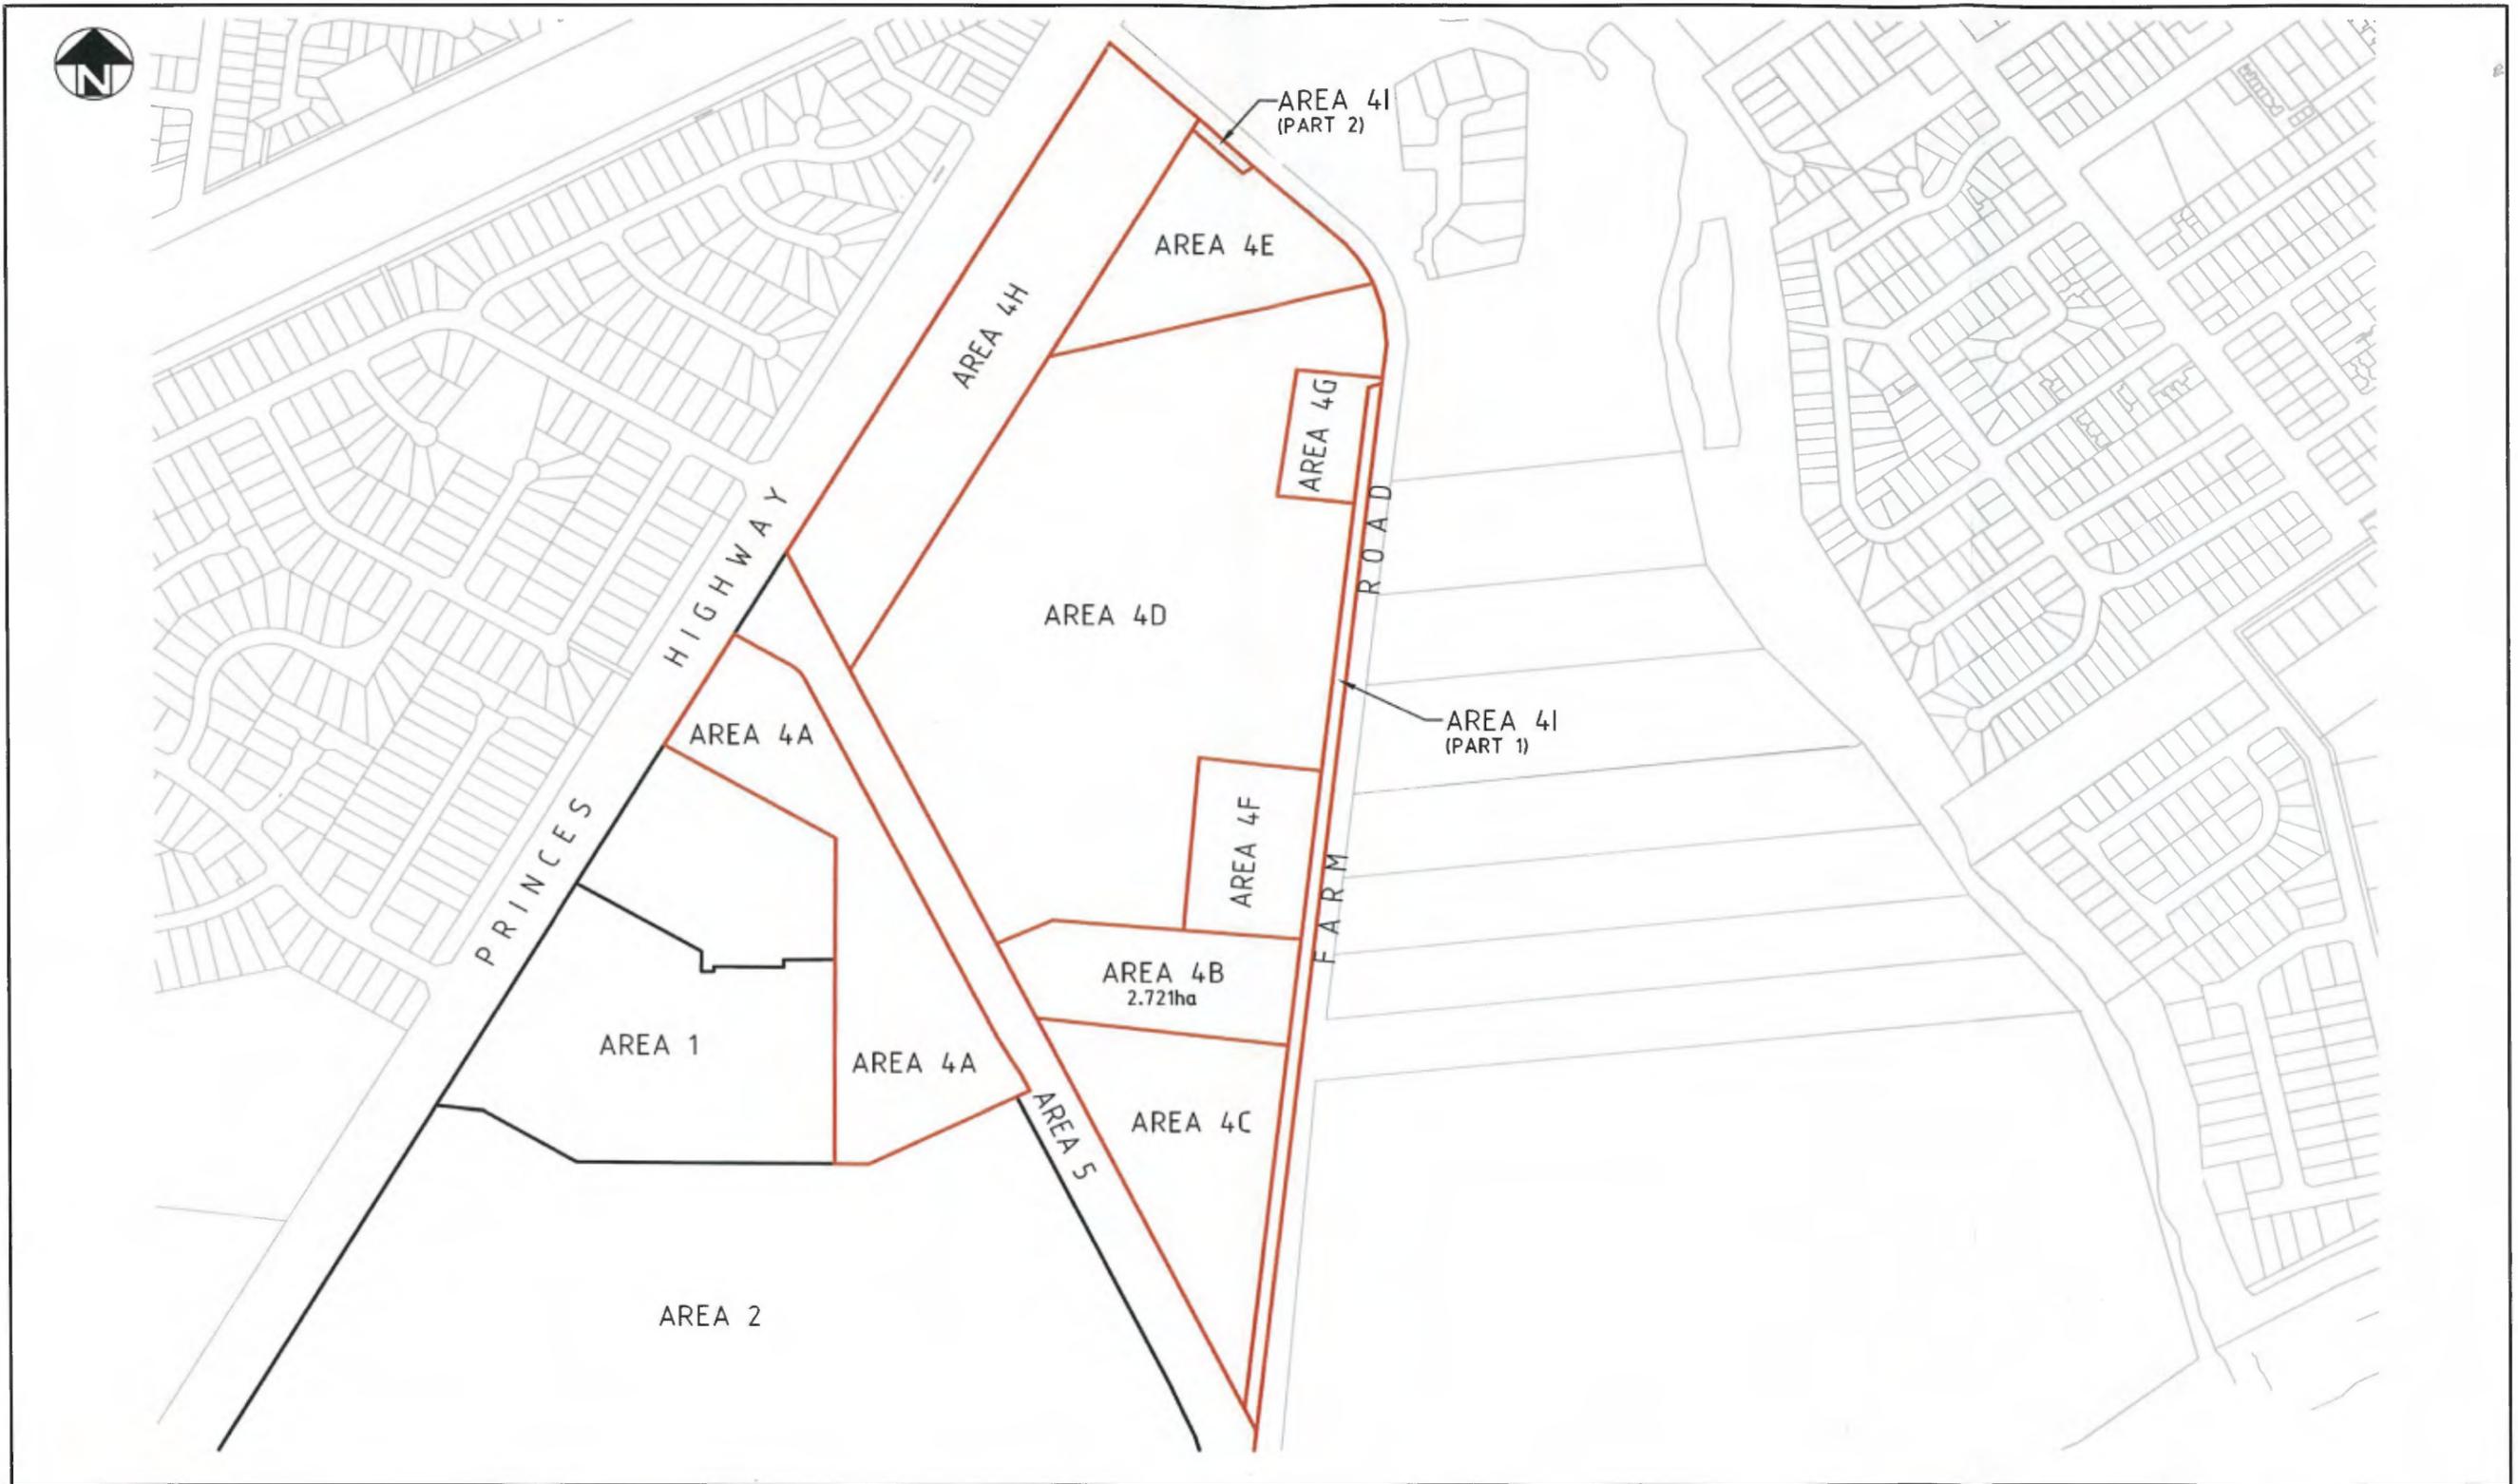
1. The former gravel track/road, which extends from Area 4F and crosses Area 4B from north to south along area 4I boundary (see Figure 3) must be removed and disposed of as part of the site development work. Such removal and disposal must be conducted in accordance with relevant regulations and guidelines.
2. Any fill or soil brought to the site must be chemically tested soil or fill that classifies as "fill material" in accordance with relevant EPA guidelines.
3. The hard rubbish pile located on the western side of the site (see Figure 3) must be removed and disposed of as part of the site development work. Such removal and disposal must be conducted in accordance with relevant regulations and guidelines.

- Asbestos containing materials (ACM) were found on the site, particularly in the vicinity of the former Hangar 5 (refer Figure 3), and have been removed as far as practicable. Small quantities of bonded ACM fragments may remain on or within the soil and may be uncovered during excavation works. These ACM fragments were not anticipated to represent a health risk to occupiers of the completed development as discussed in the audit report. If encountered during future development or use of the site, any fragments should be handled and disposed of in accordance with the relevant regulations.

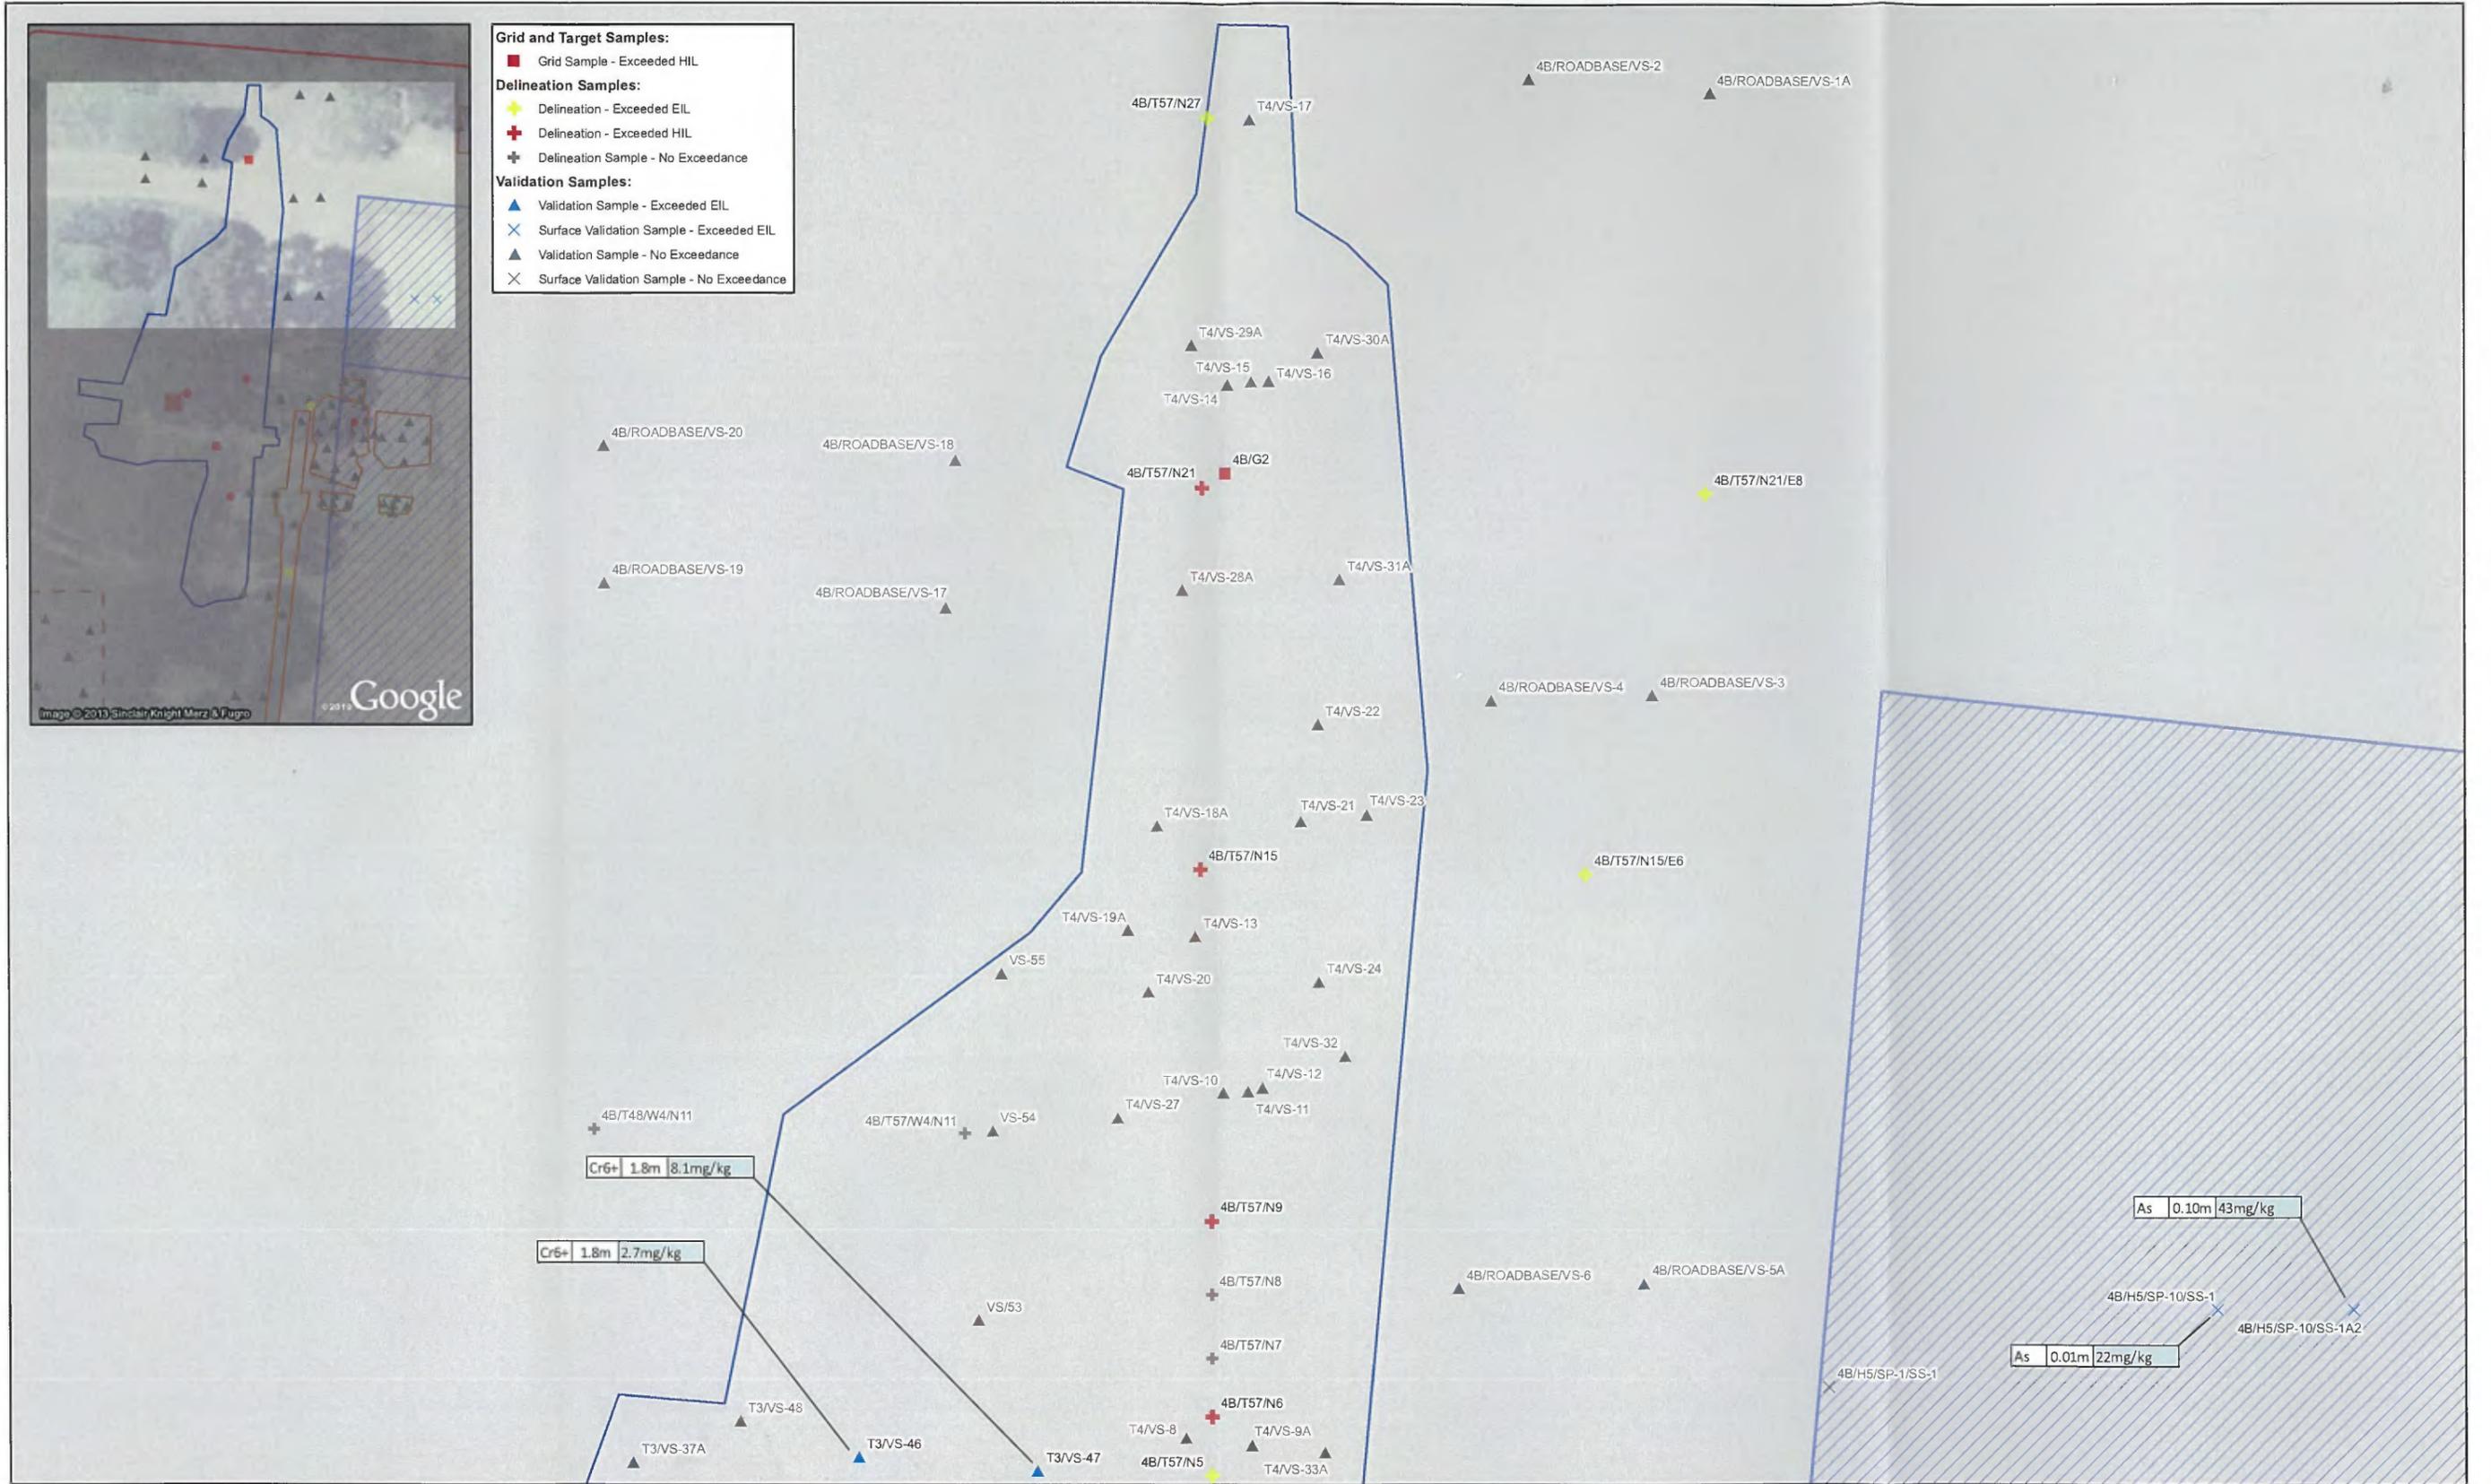
Figure 10A

CCA Impact in Area West of Hanger

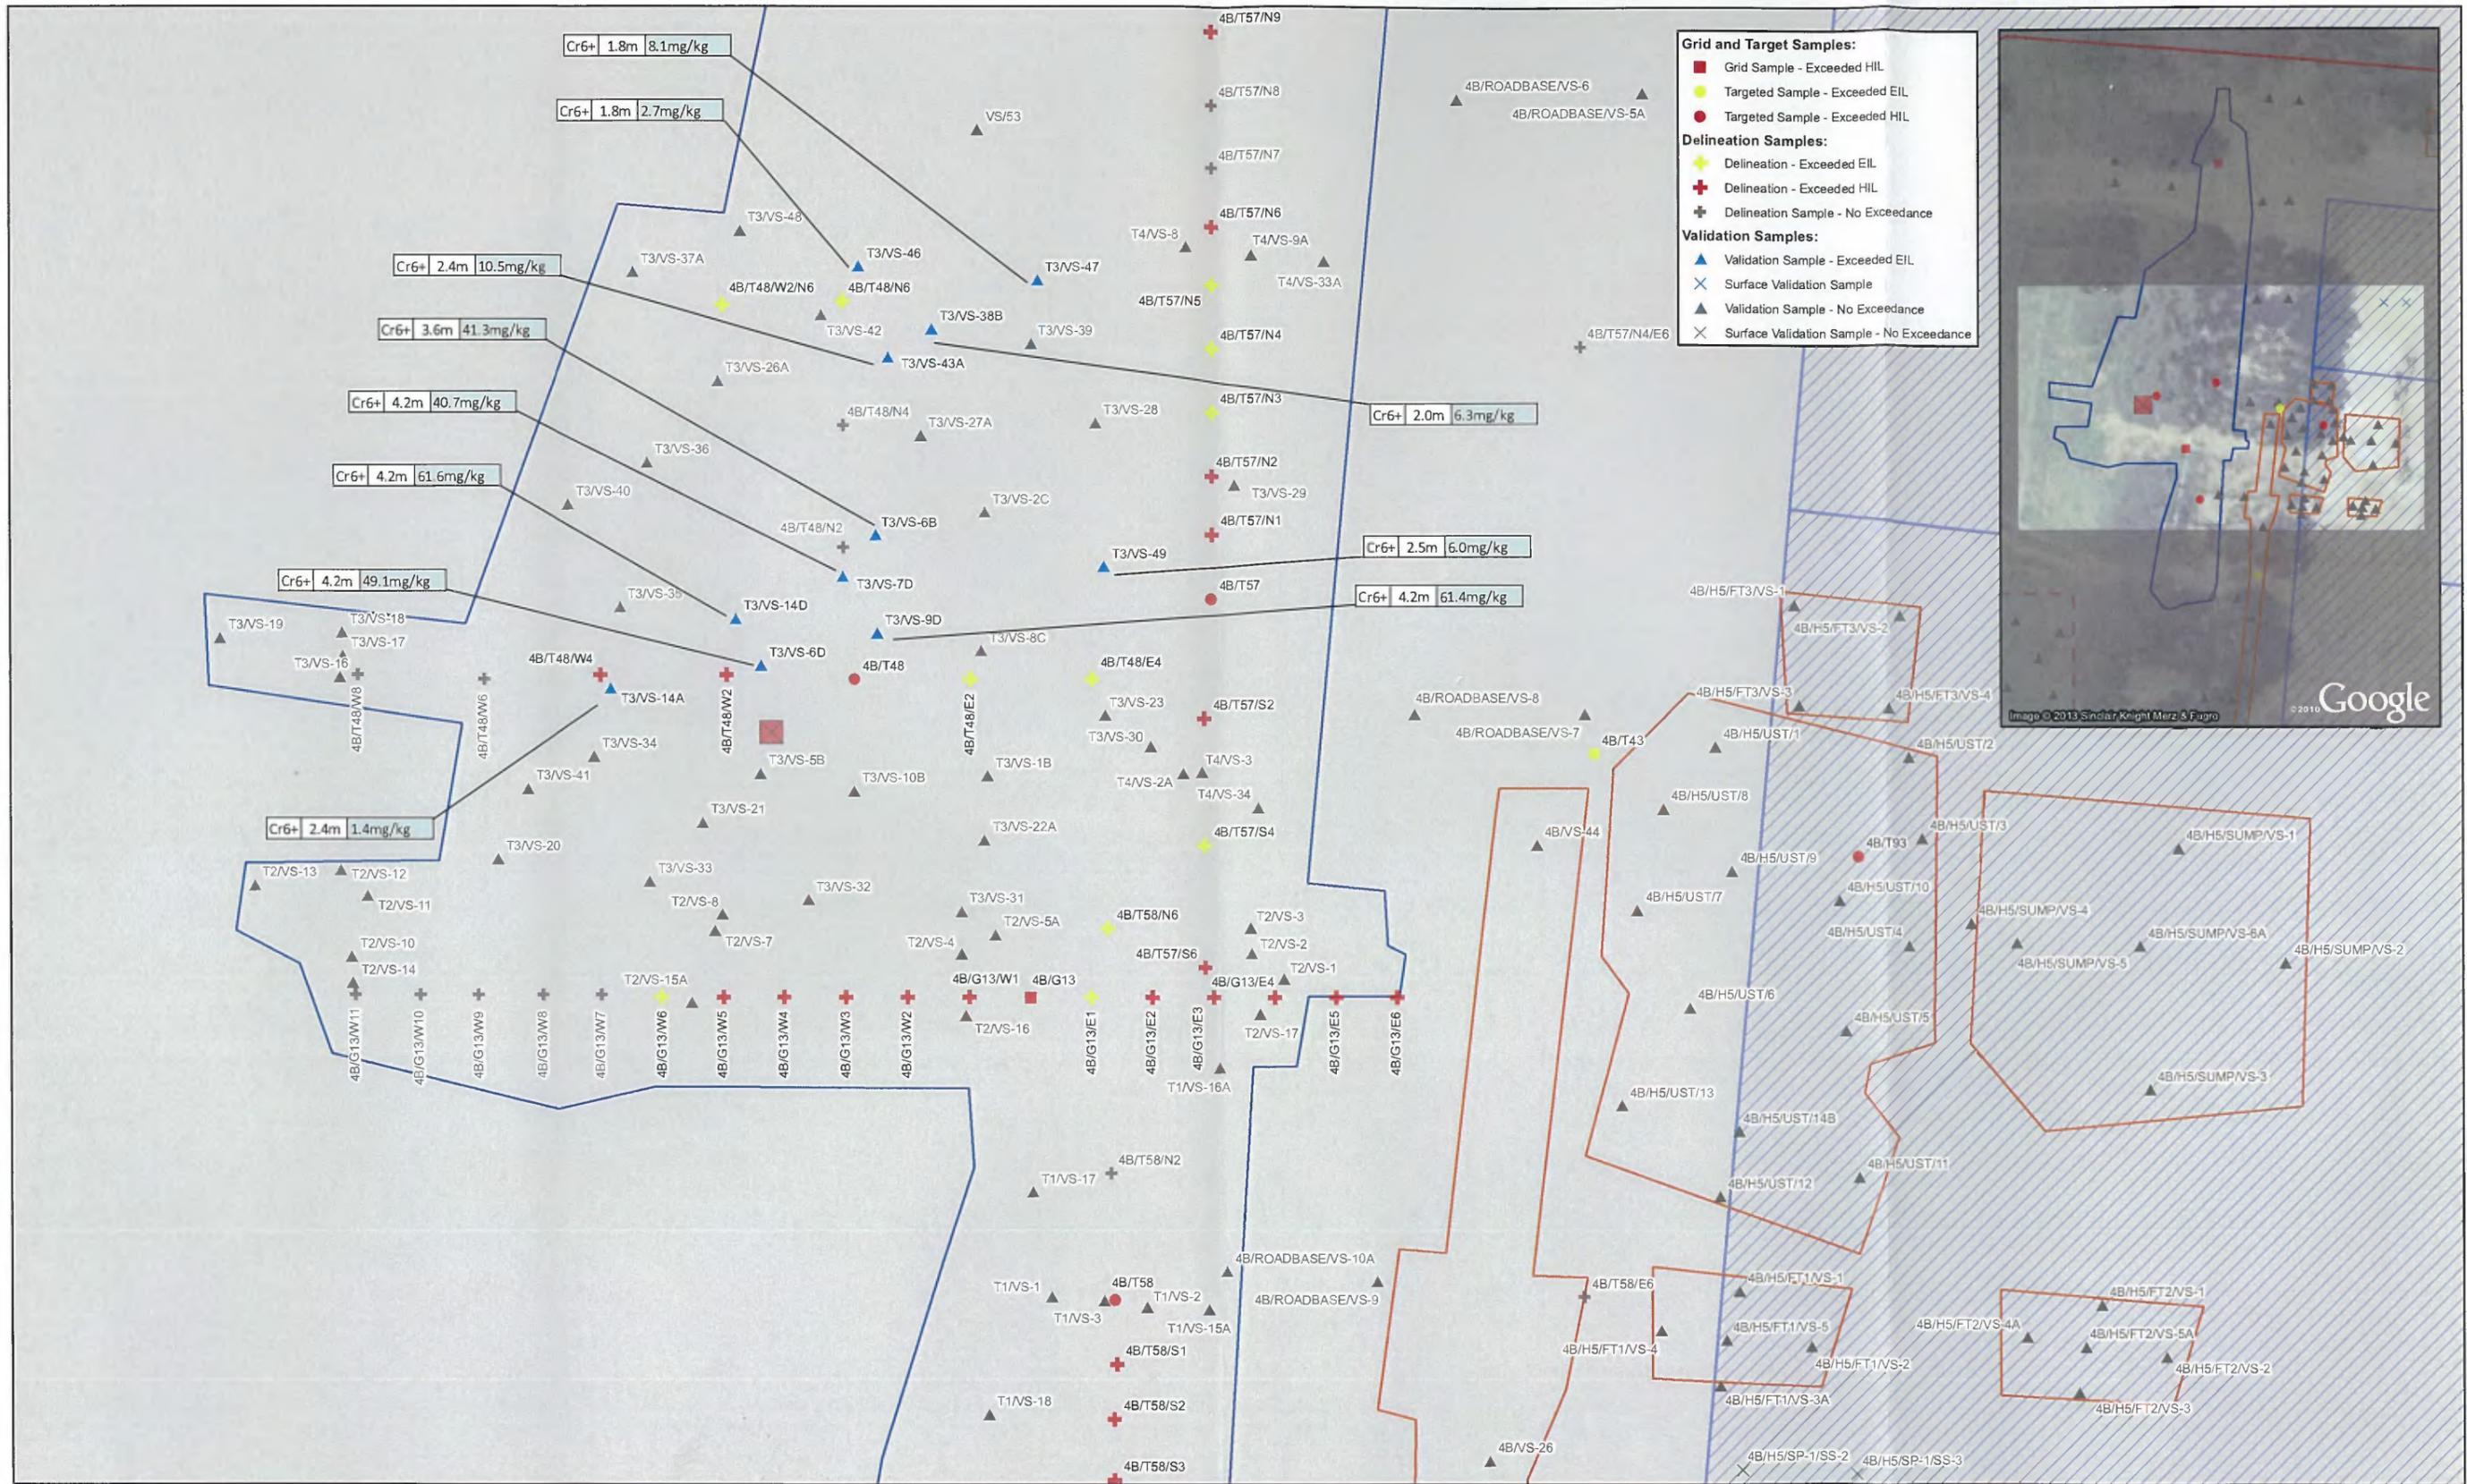
Figure 10B

CCA Impact in Area West of Hanger

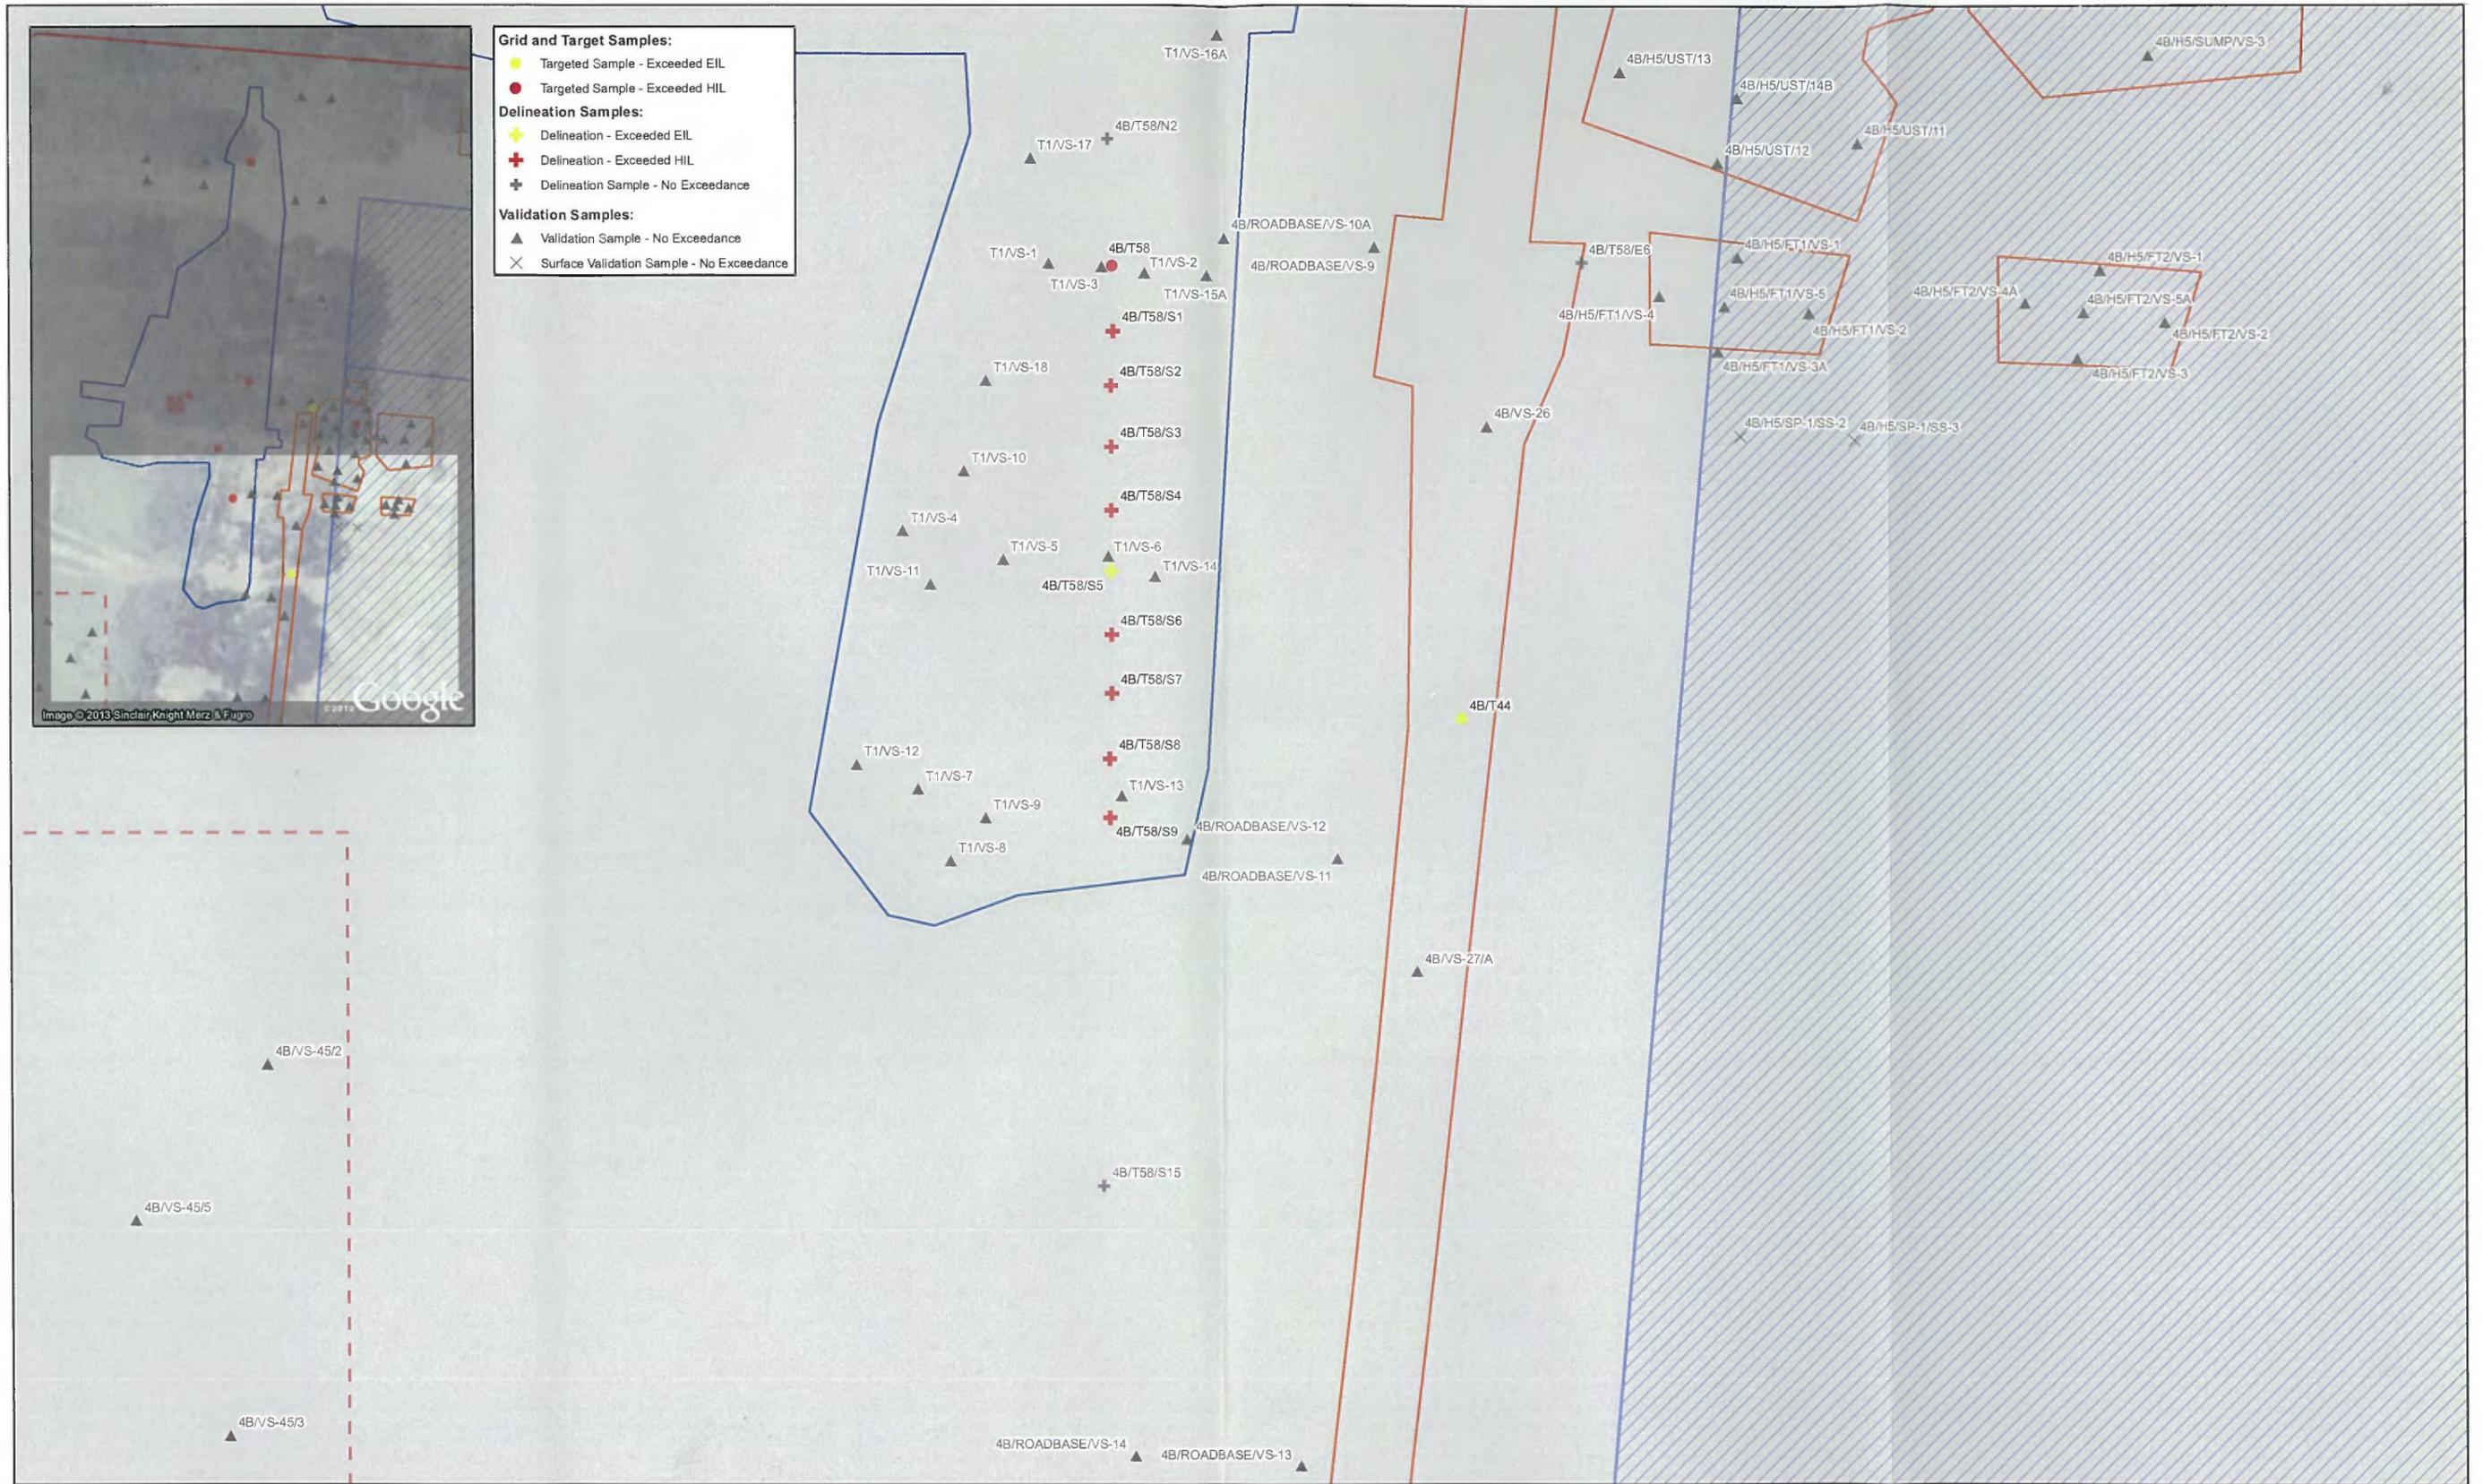
Figure 10C

CCA Impact in Area West of Hanger
