Melbourne Water Corporation

Area 4F of Riverwalk Estate, Princes Highway, Werribee,
Victoria

Environmental Audit

December 2013

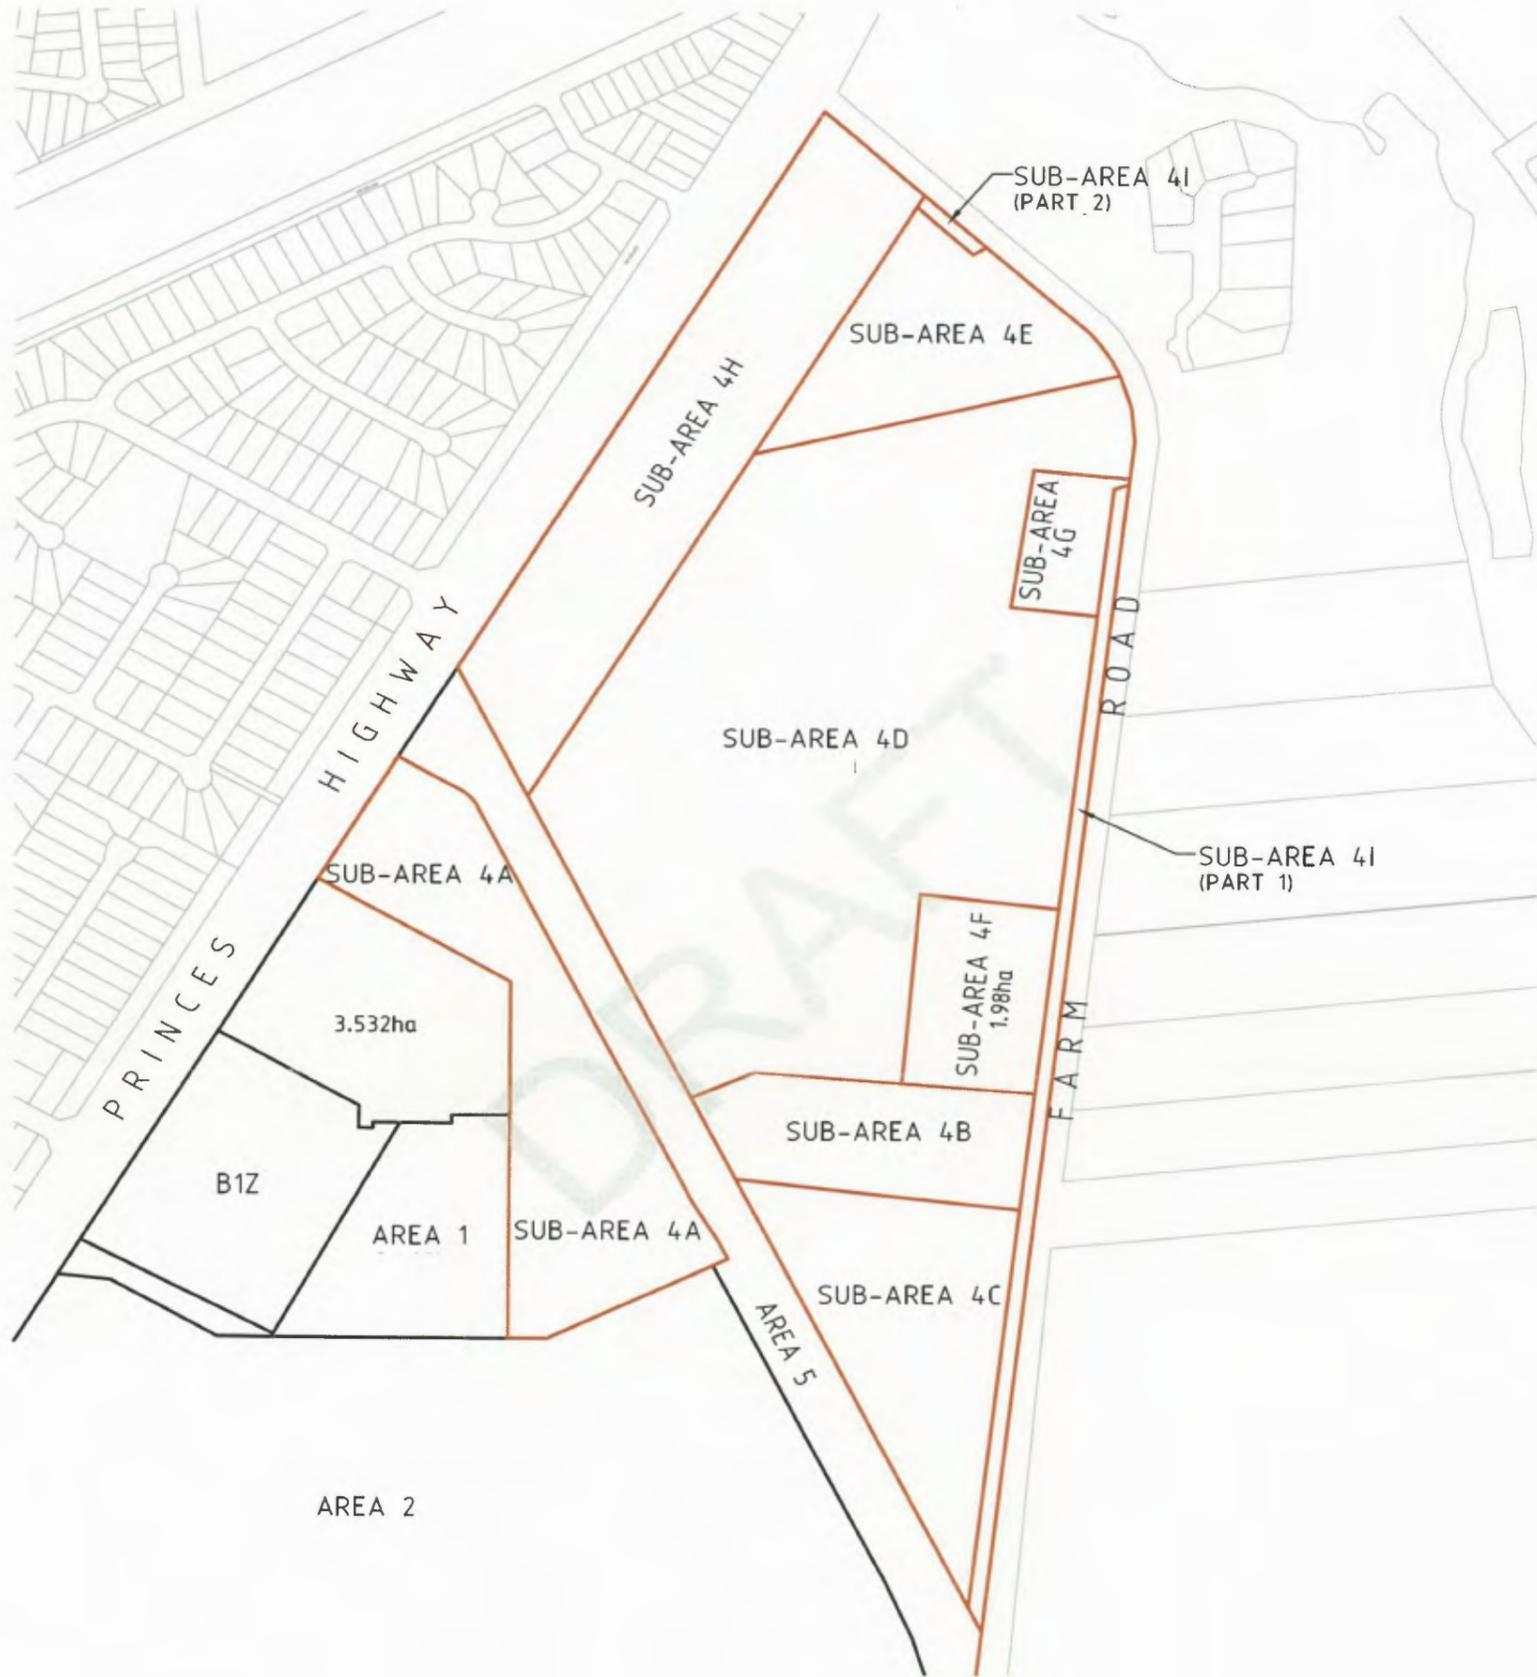
Figure 2
Riverwalk Area Site Map

Note: Image was extracted from OTEK ESA Report (above) and is not represented to scale.

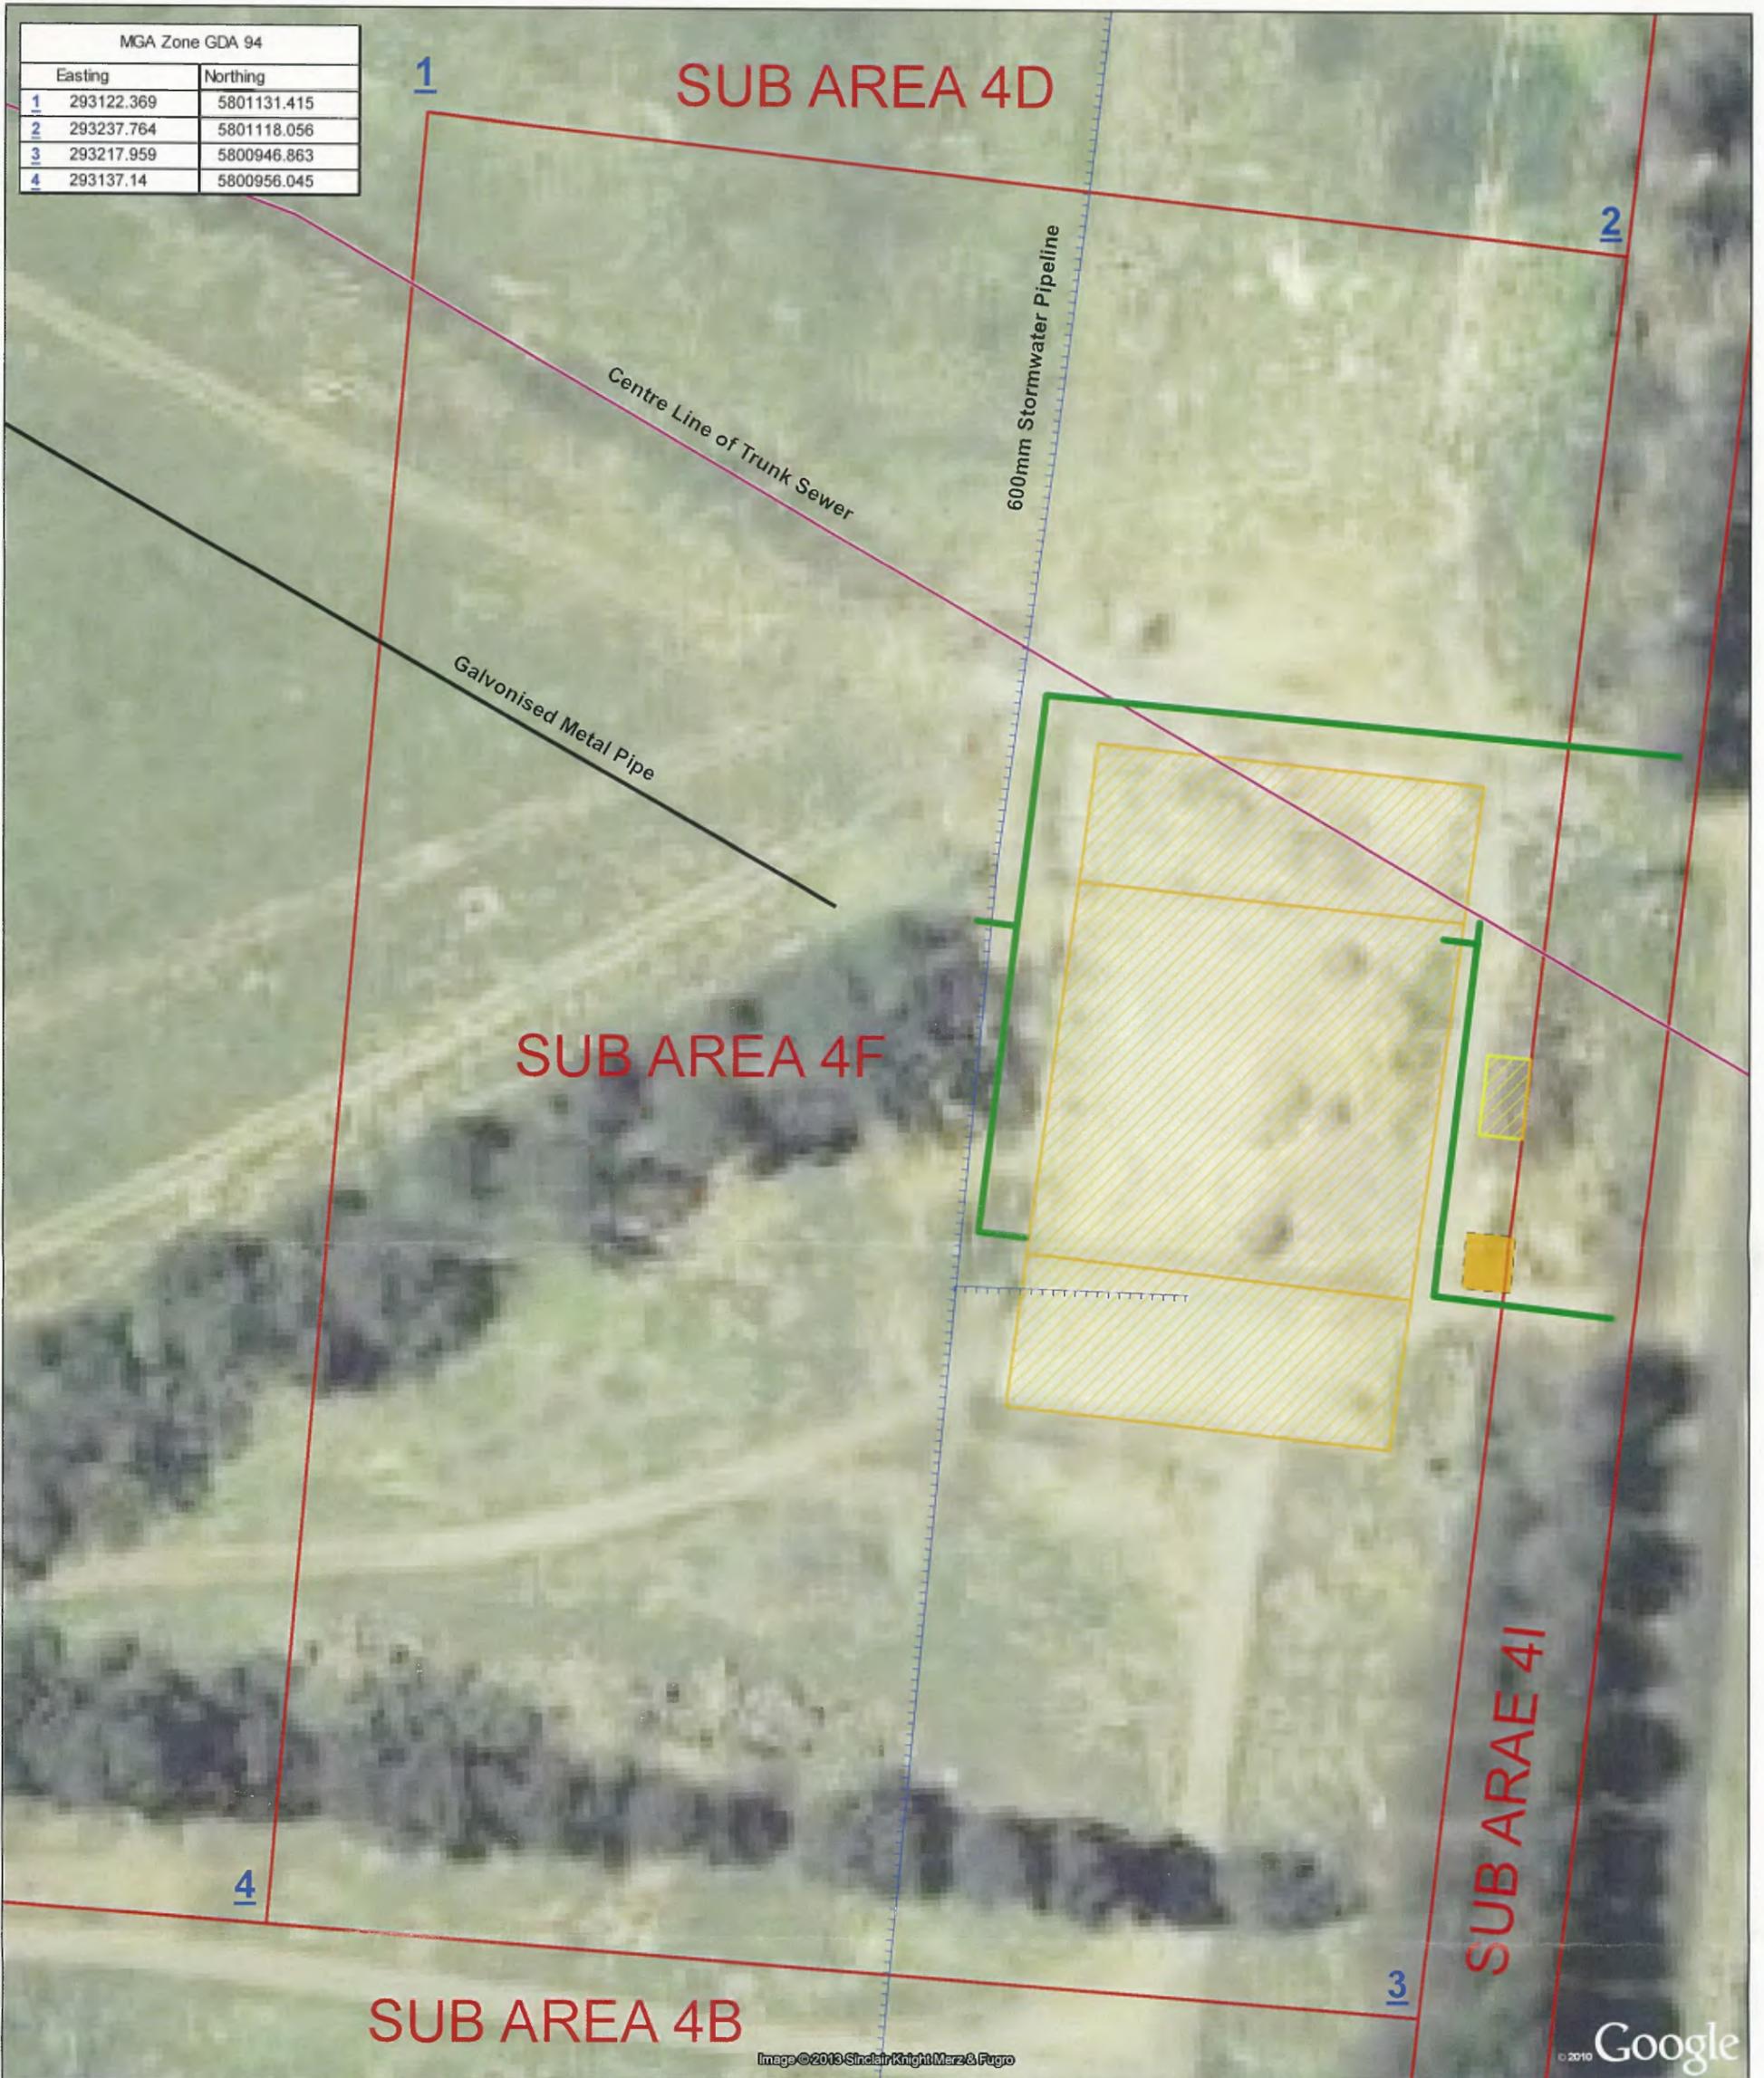
Figure 3

- Audit Areas
- Hanger Footprint
- Emergency Powerhouse
- Septic System
- Galvanised Metal Pipe (additional section)
- Stormwater Pipeline
- Trunk Sewer
- Asbestos and Galvanised Metal Water Pipe

**Audit Area 4F - OTEK Environmental Site Assessment
Historic Site Infrastructure**

- Asbestos containing materials were found on the site, particularly in the vicinity of the former Hangar 4 (refer Figure 3), and have been removed as far as practicable. Small quantities of bonded asbestos containing material (ACM) fragments may remain on or within the soil and be uncovered during excavation works. These ACM fragments were not anticipated to represent a health risk; as discussed in the audit report to occupiers of the completed development. If encountered during future development or use of the site, any fragments should be handled and disposed of in accordance with the relevant regulations.
- A stormwater pipeline and a trunk sewer were still present on site as shown in the attached Figure 3.
- Waste generated in the future as a result of the future development works should be dealt with in accordance with relevant EPA guidelines.
