## **Melbourne Water Corporation**

Area 4D of Riverwalk Estate, Princes Highway, Werribee,  
Victoria

Environmental Audit

June 2014

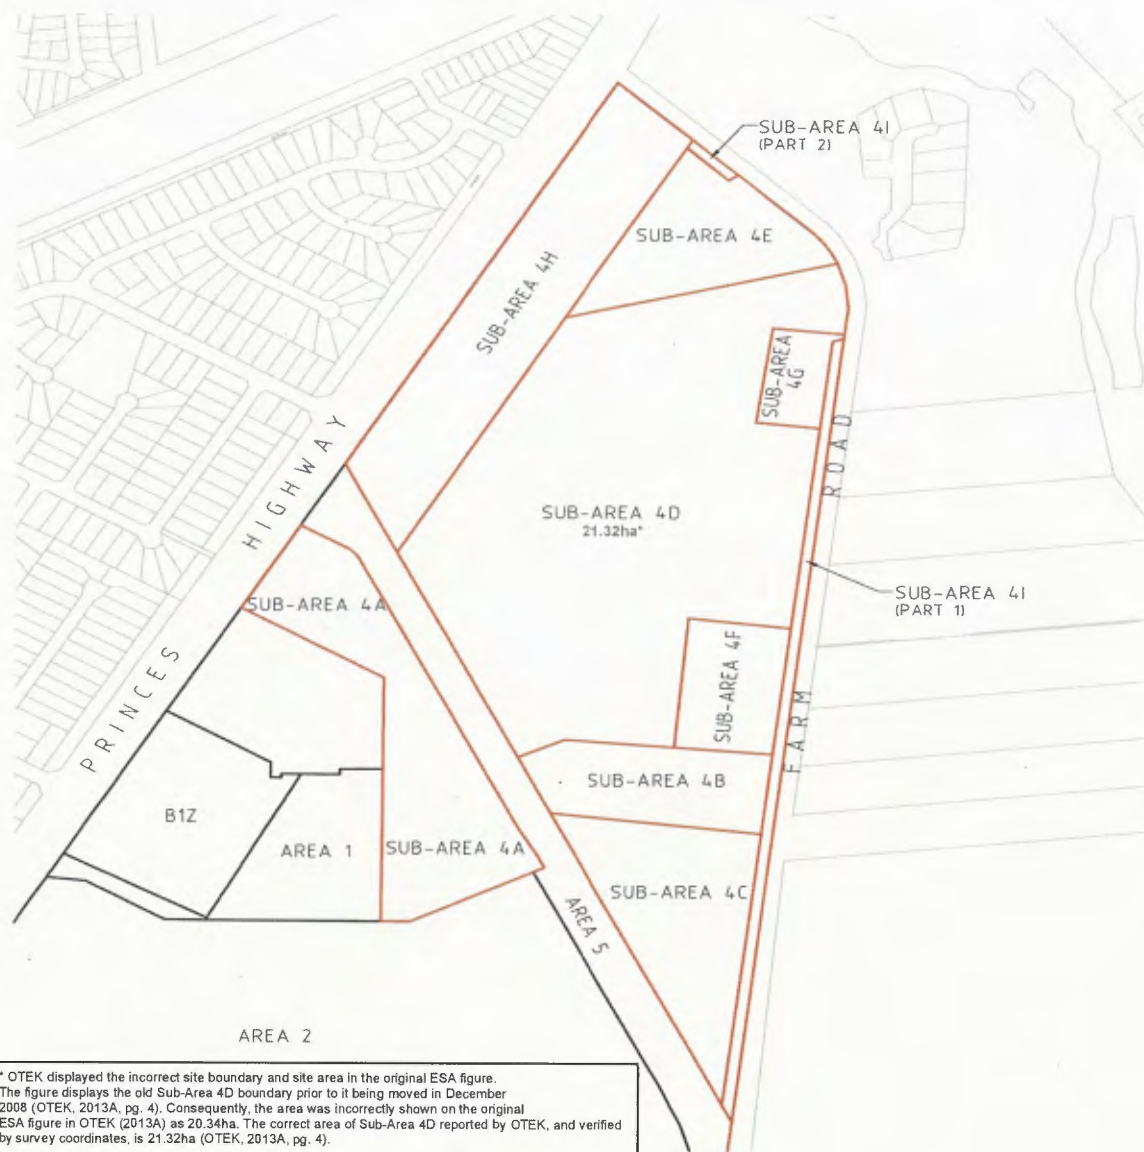
\* OTEK displayed the incorrect site boundary and site area in the original ESA figure. The figure displays the old Sub-Area 4D boundary prior to it being moved in December 2008 (OTEK, 2013A, pg. 4). Consequently, the area was incorrectly shown on the original ESA figure in OTEK (2013A) as 20.34ha. The correct area of Sub-Area 4D reported by OTEK, and verified by survey coordinates, is 21.32ha (OTEK, 2013A, pg. 4).

The area has been corrected for this figure; however the boundaries have not been changed. Figures 4 to 16 display the correct Sub-Area 4D boundary.

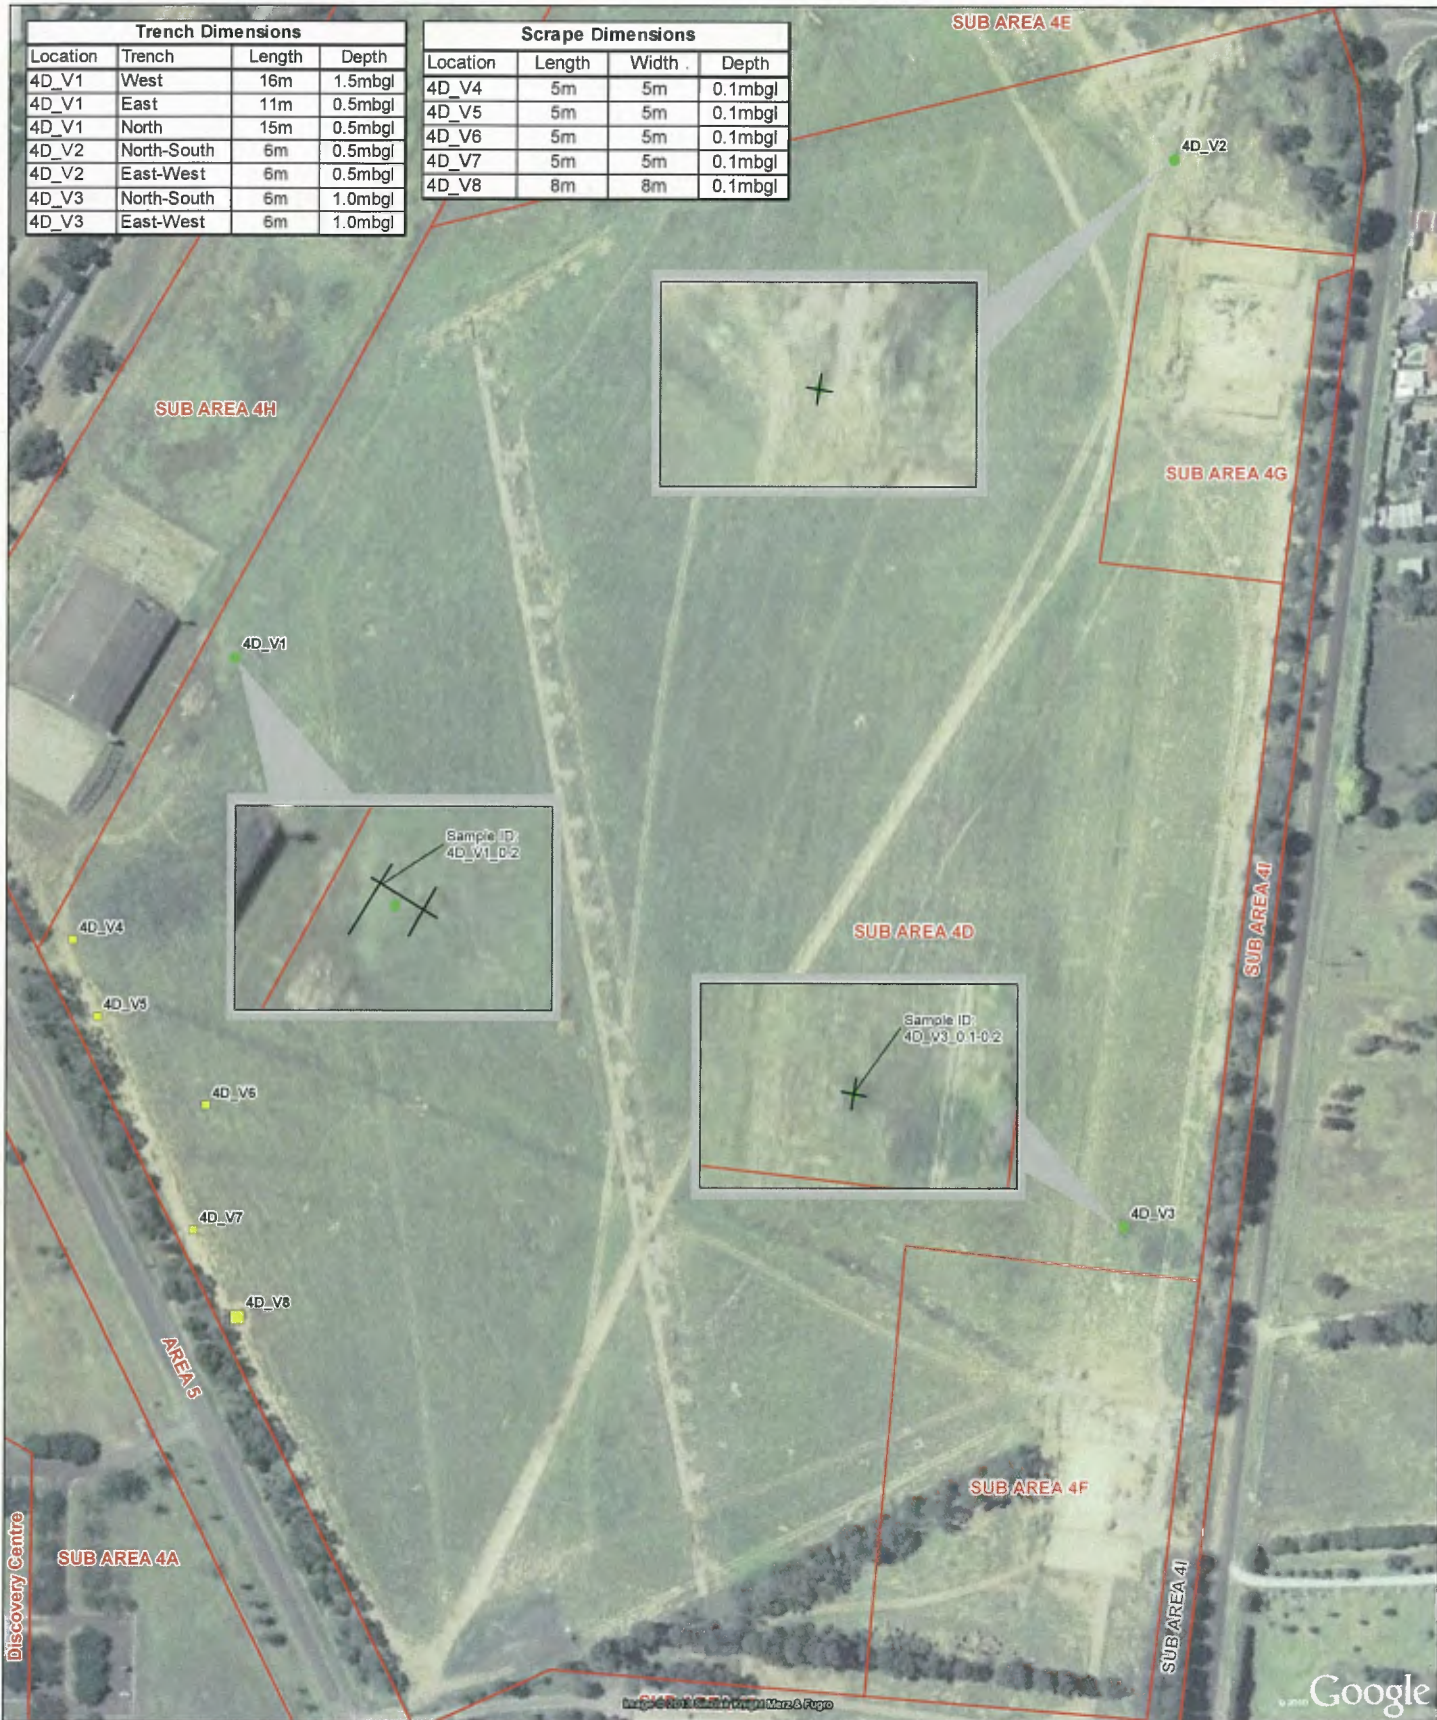
2-3 October 2013	Auditor verification	Enterra #1, Enterra Area 22, Enterra #2, south western boundary	The auditor and assistant undertook a verification assessment to address data gaps, uncertainties in O TEK's work, and to confirm O TEK's findings. Trenches were excavated at three locations, and surface scrapes at five locations (Figure 16).	Section 4.4.2
7 March 2014	Remediation	To the south of Area 4G, crossing the boundary of the site and Area 4I (opposite the letter box of 35 Farm Road)	TEC removed ACM fragments from the surface of the site. The ACM was observed by the auditor during a site inspection of Areas 4I and 4G, undertaken on 25 February 2014.	Section 5.3.2
29 June 2014	Auditor final site inspection	Not applicable	The auditor undertook his final site inspection.	Sections 4.4.1 and 5.5.4

- LEGEND**
- Audit Areas
  - Auditor Verification Trench
  - Verification Trench Location
  - Verification Surface Scrape (5x5m)
  - Verification Surface Scrape (8x8m)
