Melbourne Water Corporation

Area 4B of Riverwalk Estate, Princes Highway,
Werribee, Victoria

Environmental Audit

May 2014

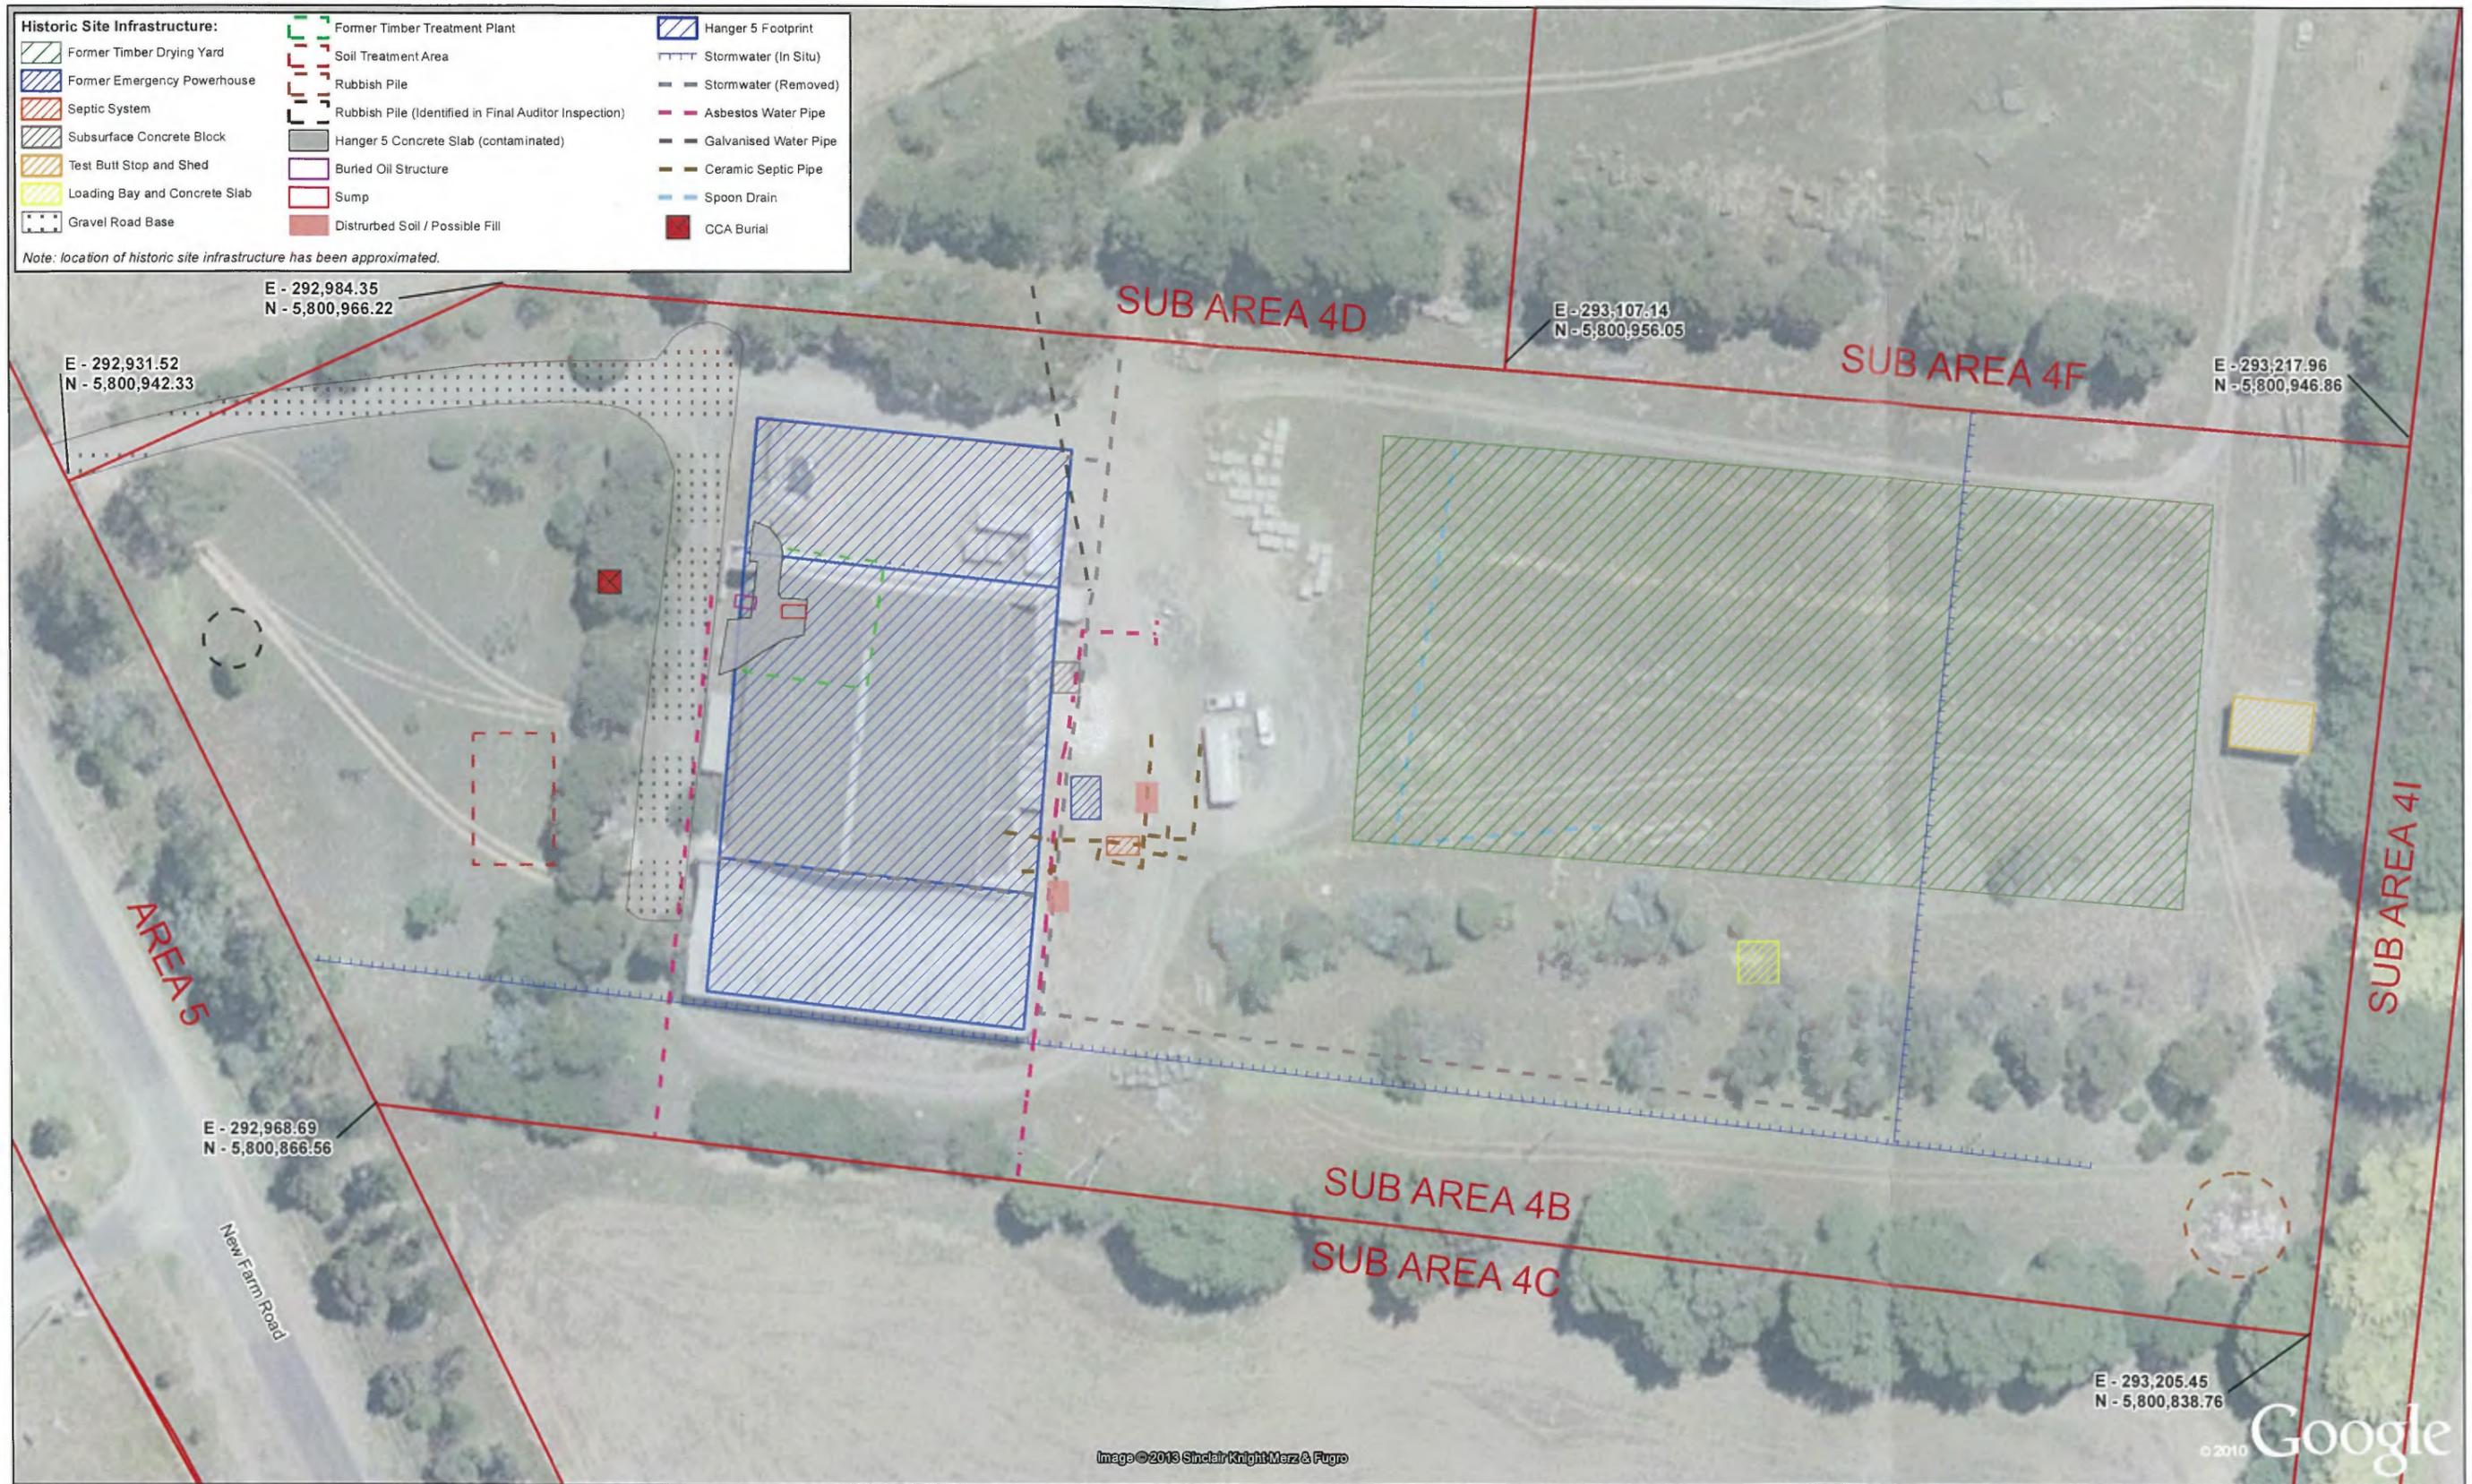
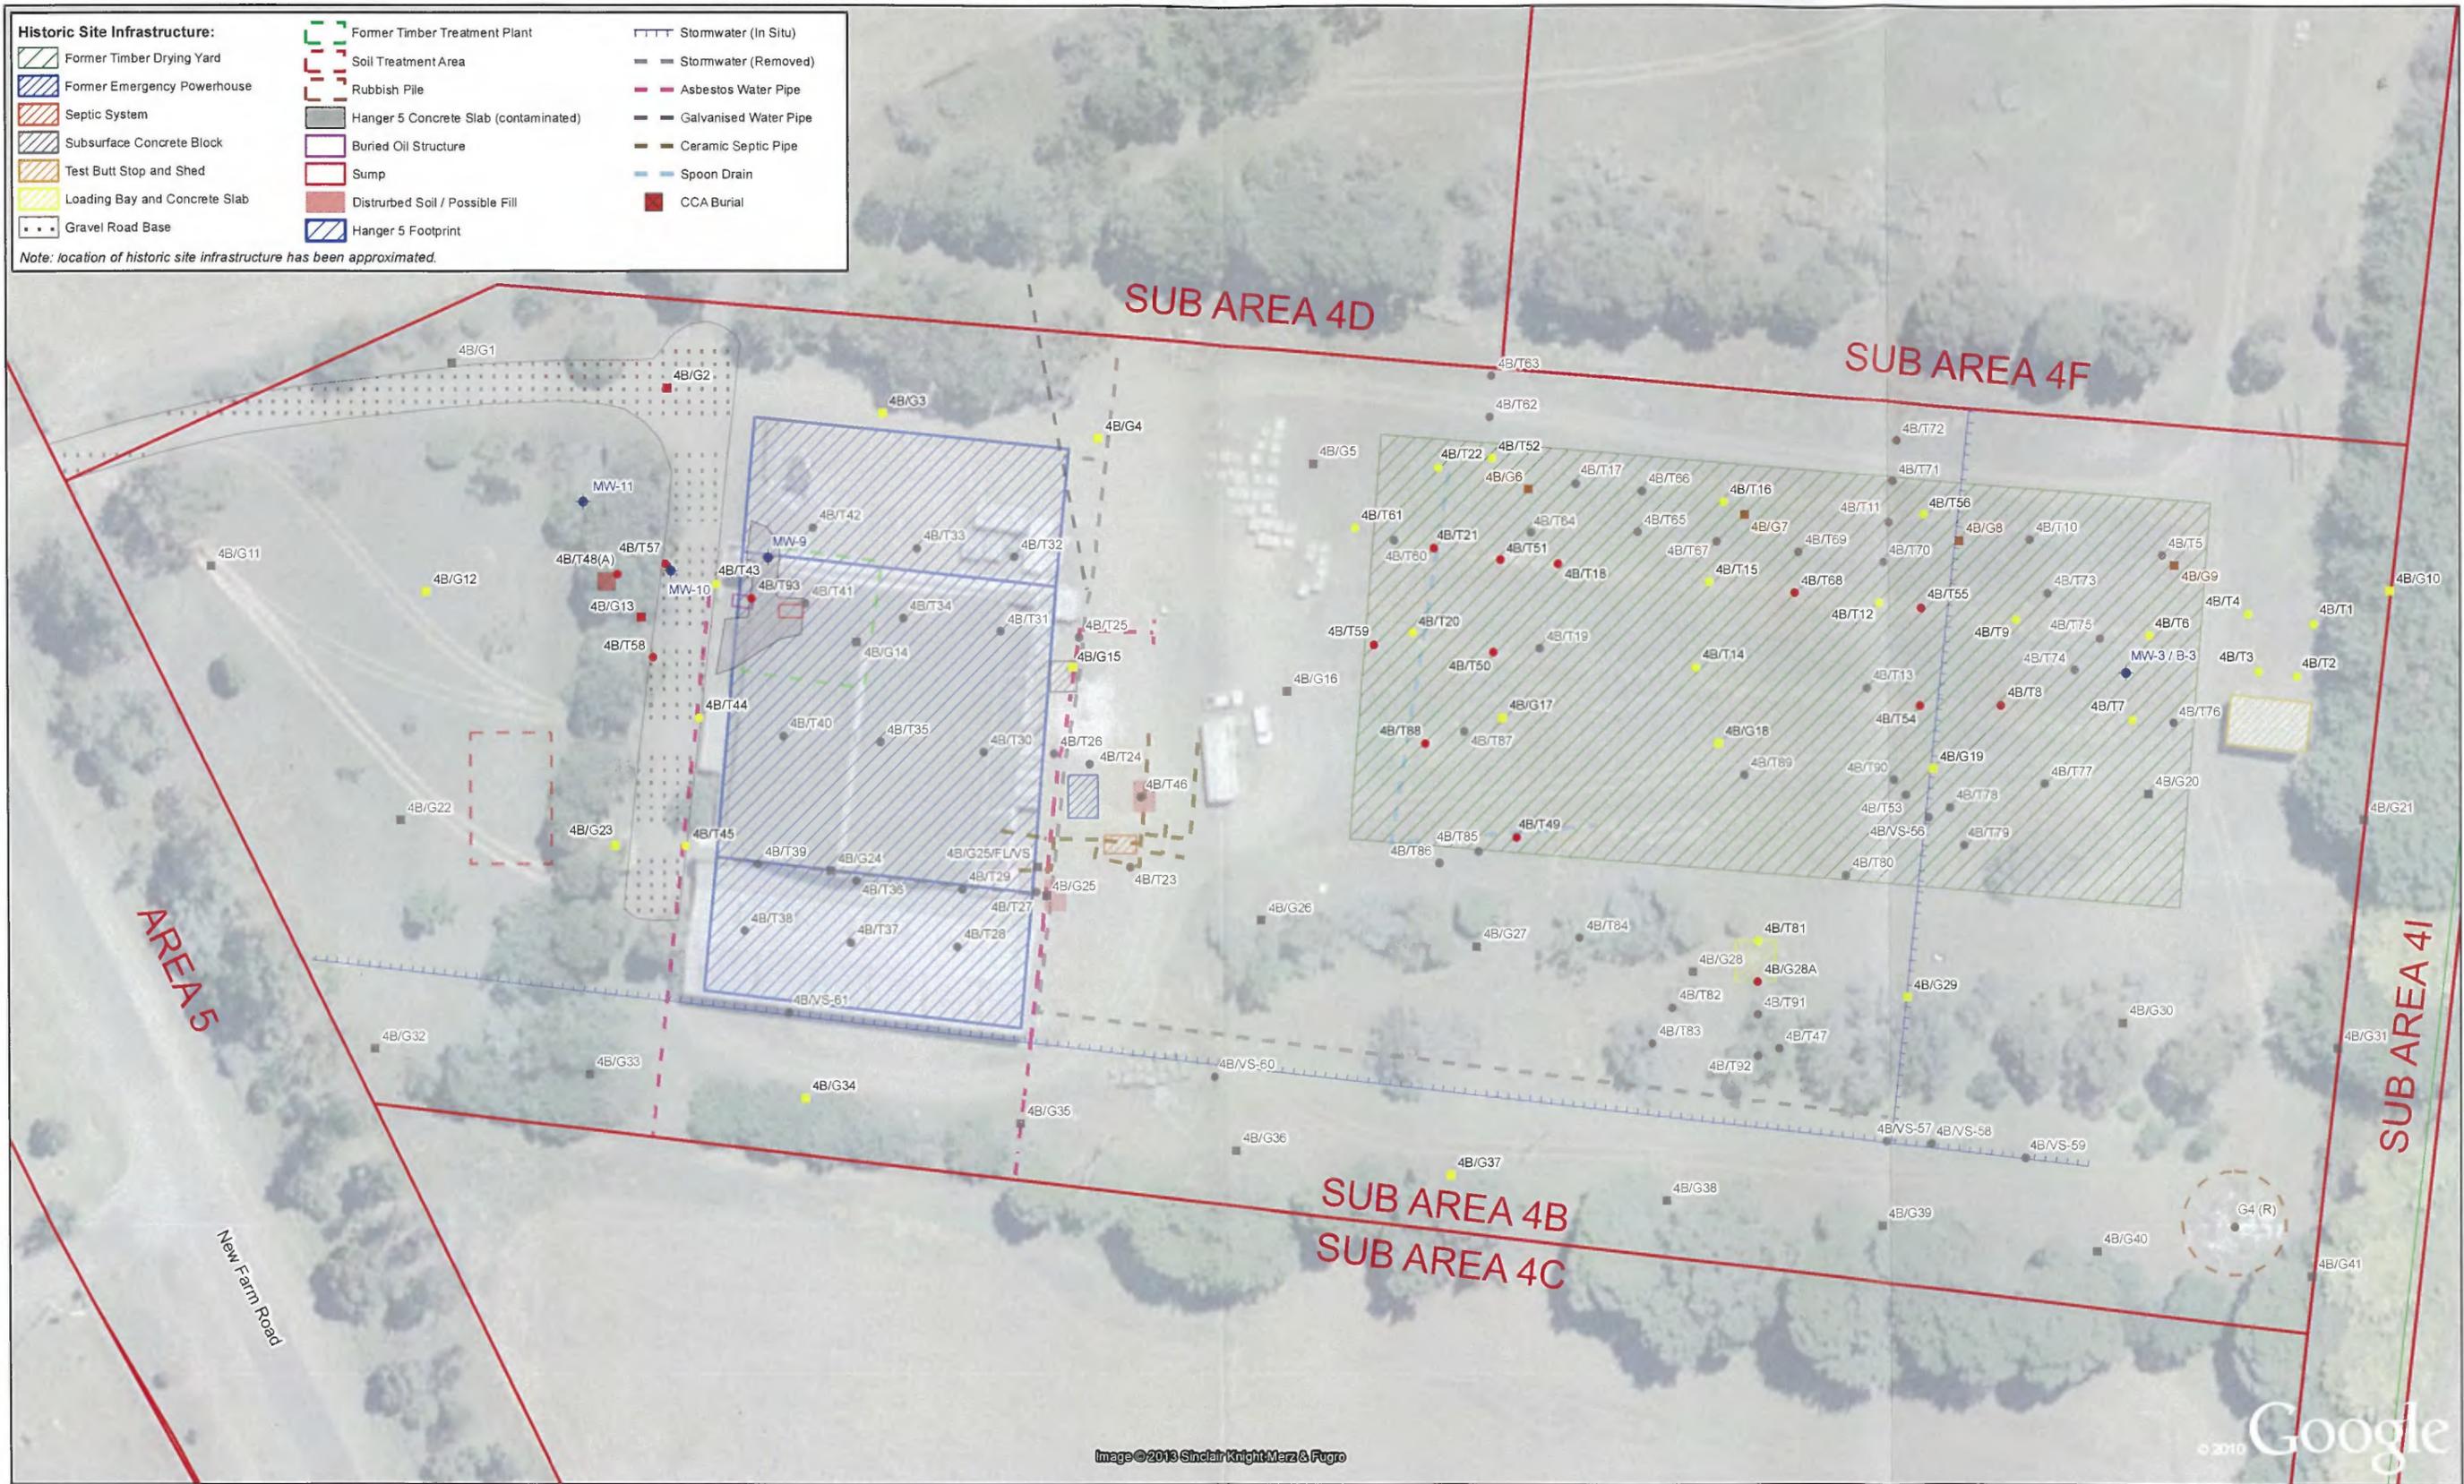
Grid, Targeted and Monitoring Well Locations **Figure 4**

The auditor noted that the loading bay appeared to be in close proximity to 4B/G28 and 4B/G28A (refer to Figure 4). 4B/G28 was a grid location as discussed in Section 5.1.1 and 4B/G28A was collected due to the observation of a degraded plastic container during grid sampling works.

During remediation of exceedances of CCA in the former timber drying yard (discussed further in Section 5.5.2), a concrete spoon drain was identified in the proximity of 4B/T20, 4B/T21, 4B/T22, 4B/T49, 4B/T85, 4B/T86 and 4B/T88 (refer to Figure 4). The spoon drain was found to be an 'L' shaped structure on the western side of the former timber drying yard (refer to Figure 3). OTEK (2012b) reported that the spoon drain was associated with the former TTP operations. Photographs of the spoon drain were included in Appendix E (OTEK, 2012b).

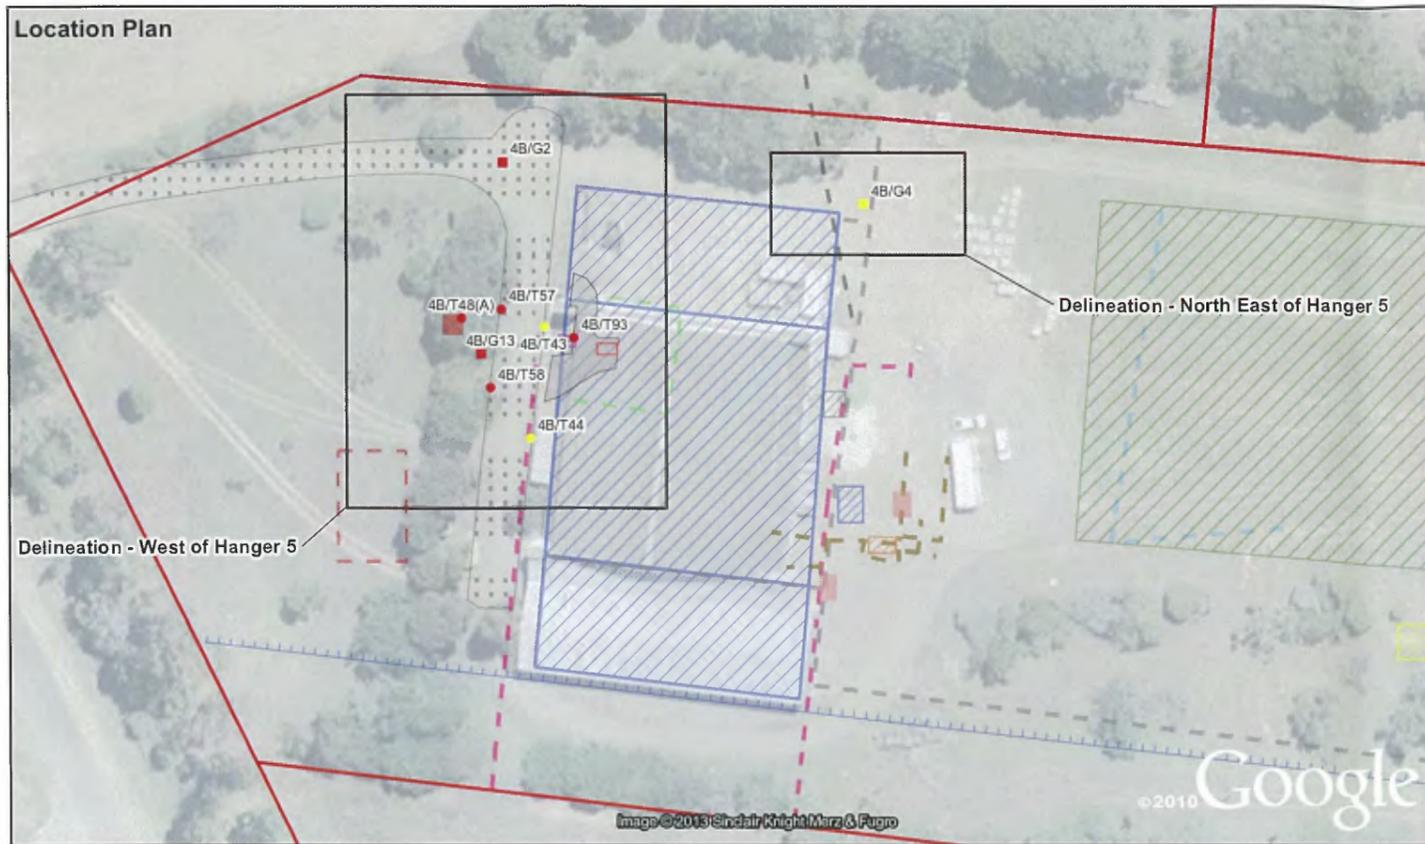
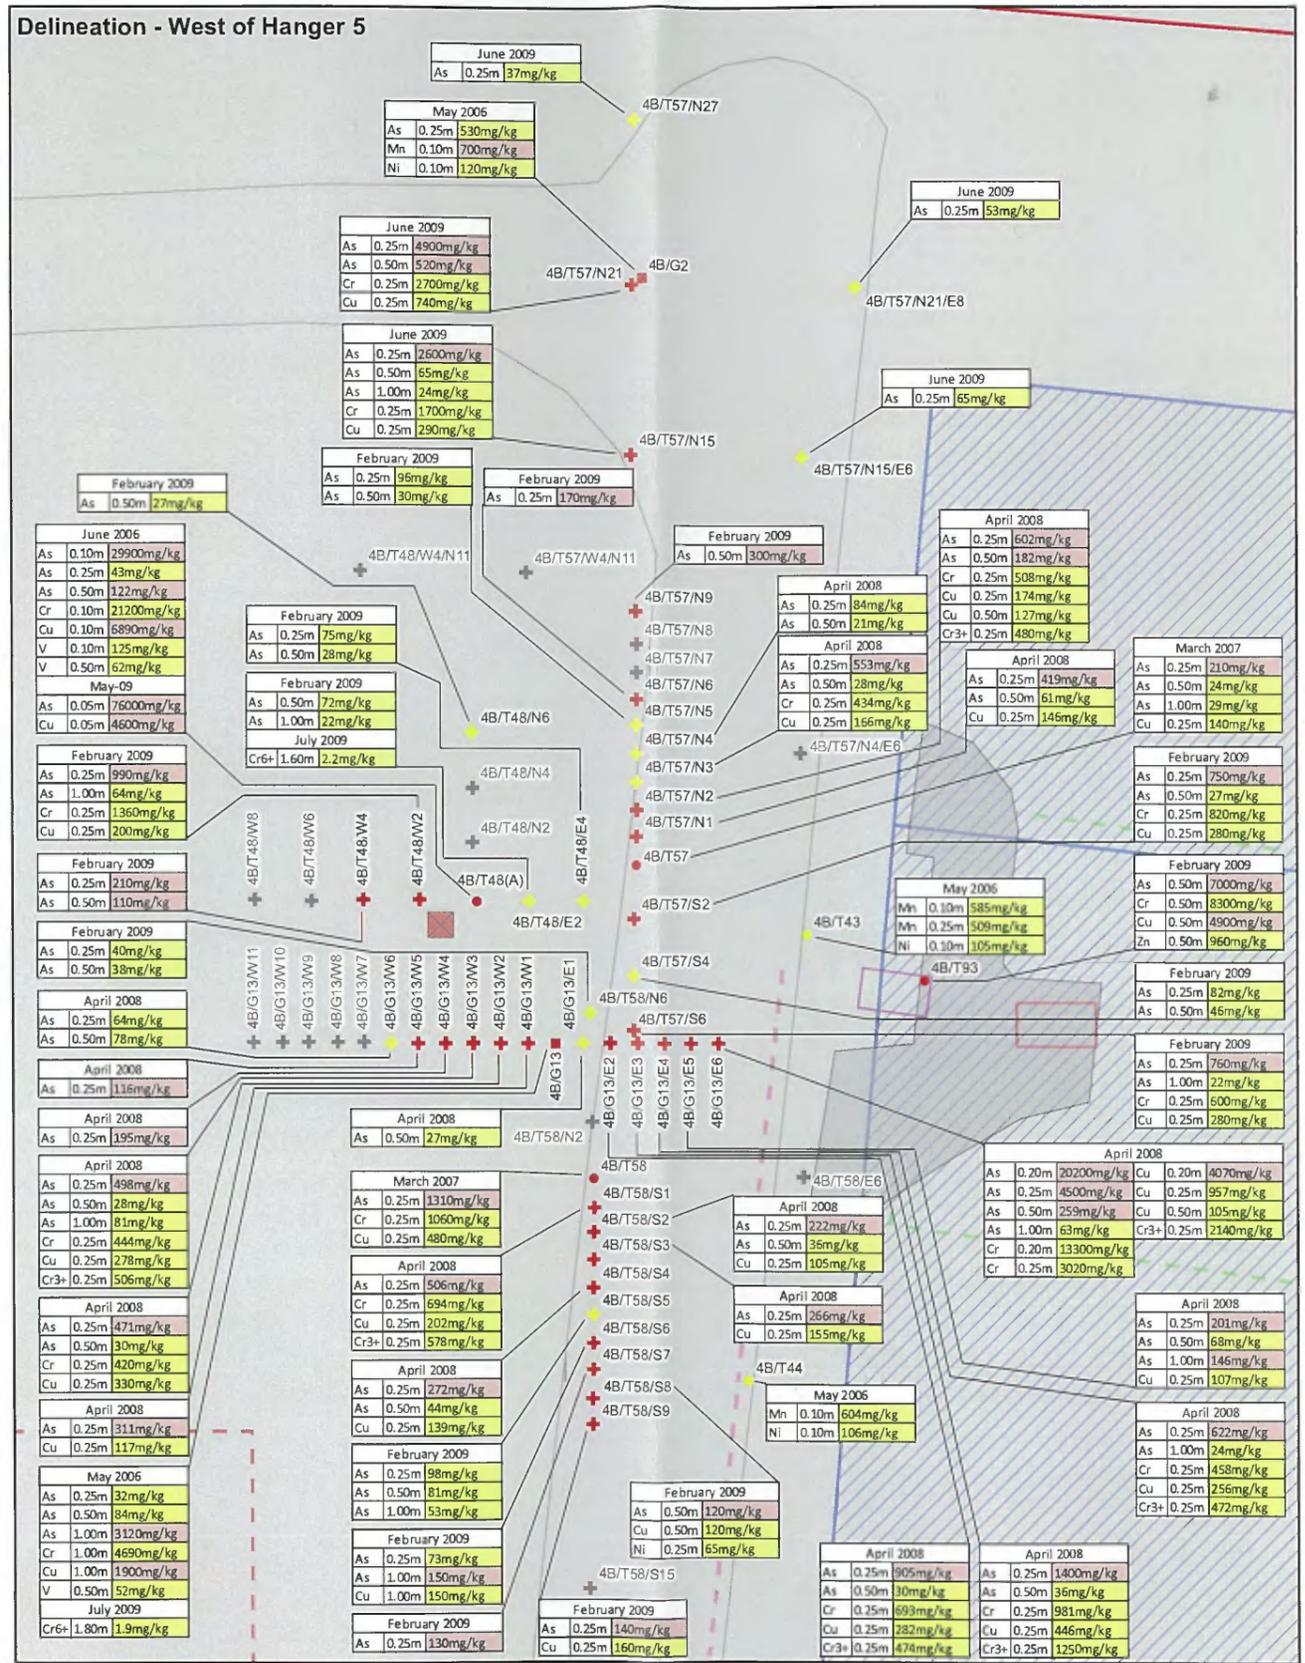
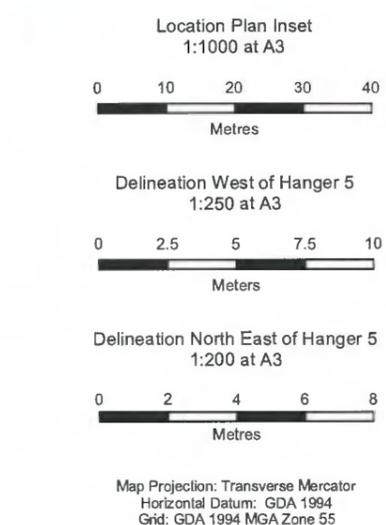
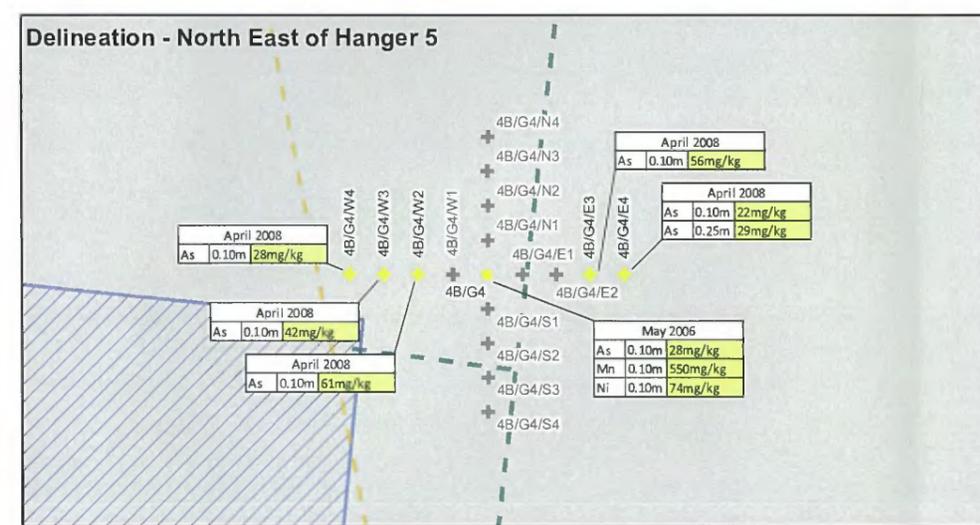
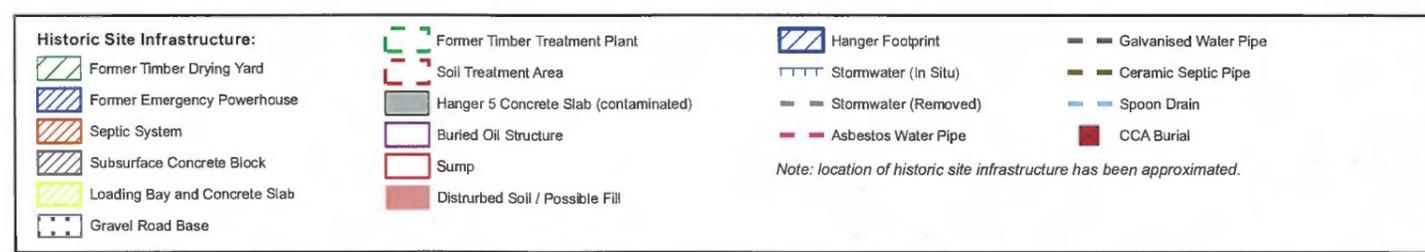
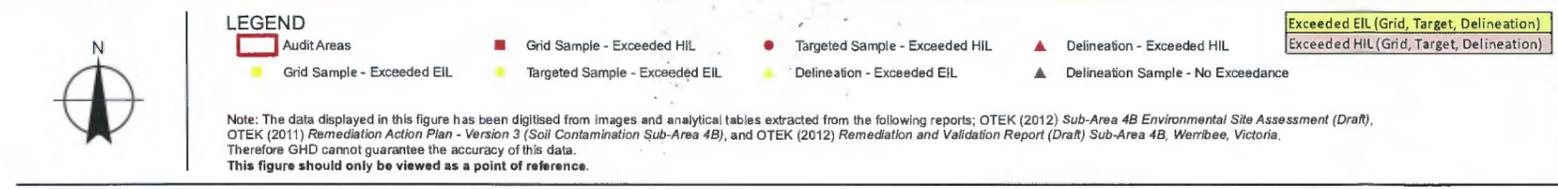
Grid and Targeted Sample Exceedances **Figure 5**

A total of 22 test pit locations (i.e. 4B/G17, 4B/G18, 4B/T7, 4B/T8, 4B/T9, 4B/T12, 4B/T14, 4B/T15, 4B/T18, 4B/T20, 4B/T21, 4B/T49, 4B/T50, 4B/T51, 4B/T52, 4B/T54, 4B/T55, 4B/T56, 4B/T59, 4B/T61, 4B/T68, 4B/T88) within the former timber drying yard reported concentrations of arsenic, chromium and / or copper above the EIL and HIL A (in some instances). The maximum concentration of arsenic (412 mg/kg), chromium (513 mg/kg) and copper (322 mg/kg) was reported at surface sample 4B/T50/0.05. Remediation and successful validation was undertaken at these 22 CCA hotspots. A 23rd location (4B/T5) was also excavated and validated; however, concentrations at this location were below the EIL and HIL A. The remediation and validation works are discussed in Section 5.5.2. The exceedances are shown on Figure 5.

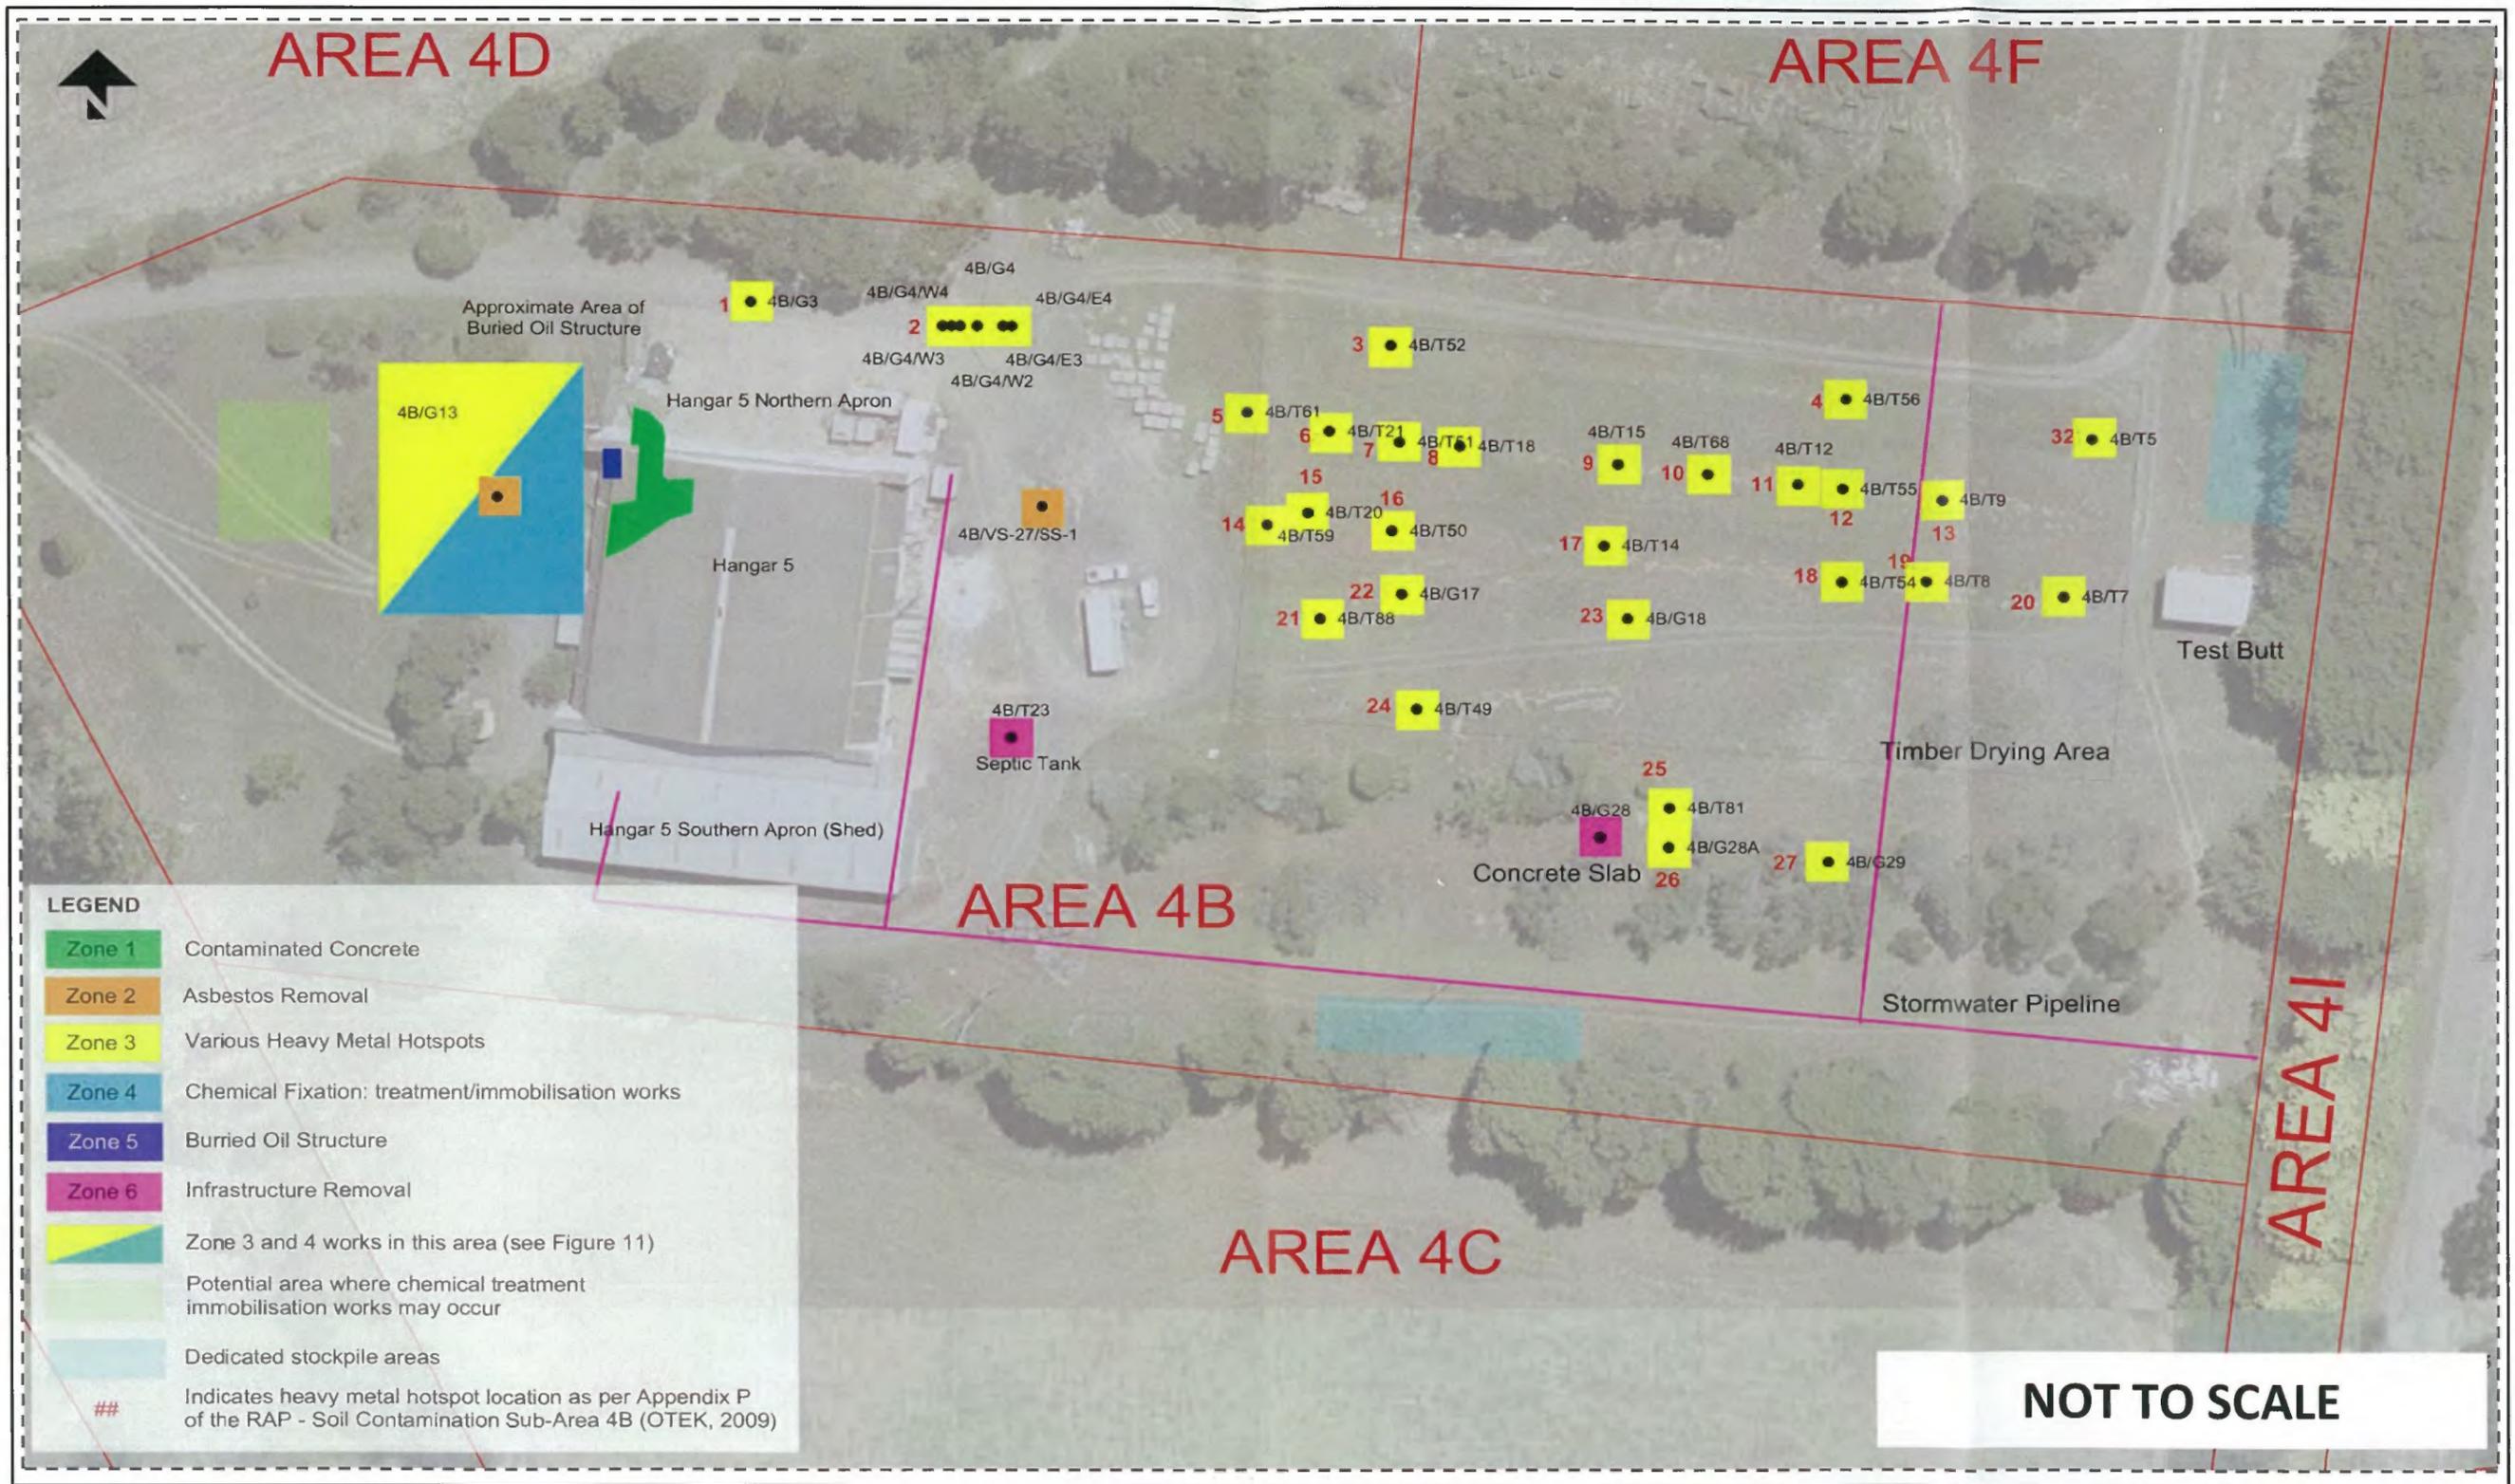
Figure 6

O TEK undertook delineation sampling in an attempt to determine the extent of CCA contamination identified in the area west of Hangar 5 as well as some of the locations on the general site area. The results of the delineation sampling are discussed Section 5.3. The remediation and successful validation in the area west of Hangar 5, timber drying yard, and general site area is discussed in Sections 5.5.2, 5.5.3 and 5.5.5 respectively. The delineation sampling exceedances are displayed in Figure 7.

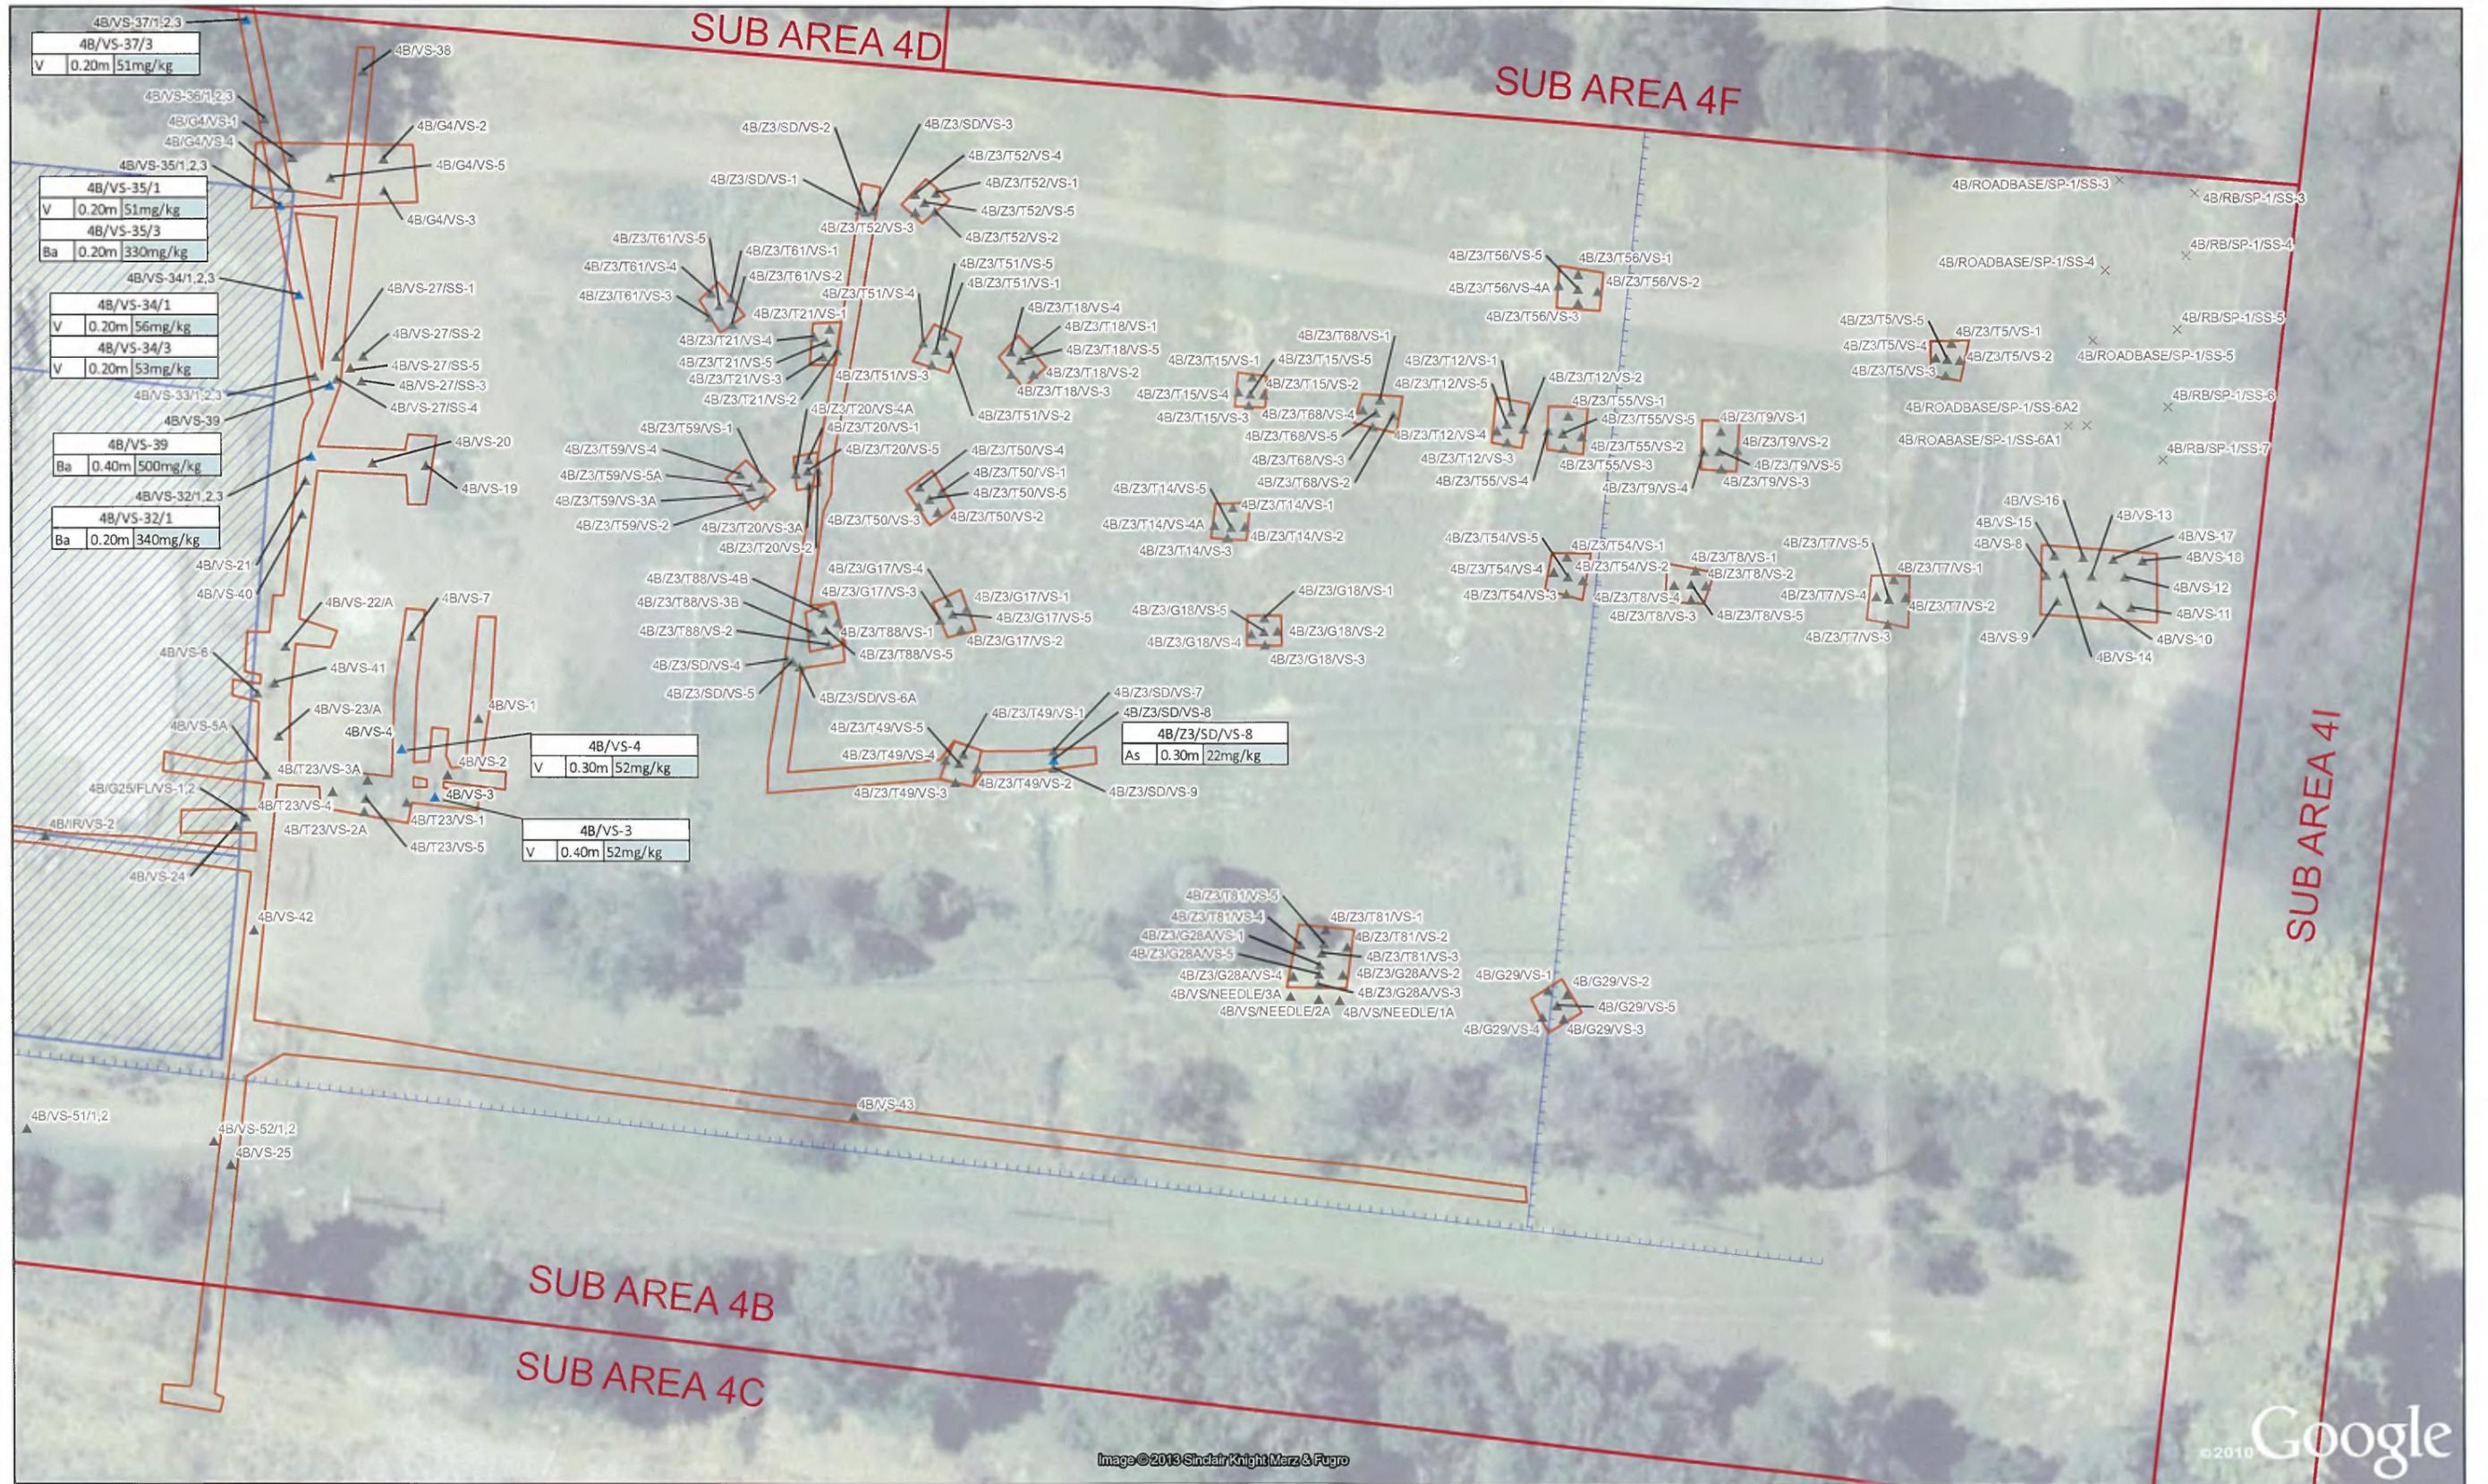
Figure 7
OTEK Proposed Remediation Zones

1 July 2009	<p>Site meeting and inspection.</p> <p>Zone 3 and 4 remediation areas (as shown on Figure 7) were inspected. Within the area west of Hangar 5, the auditor and his auditor's assistant observed 'green stained' soils at depth. Rusted metal was also observed within the excavation and was thought to be associated with the 'buried drums' identified in the site history review.</p> <p>At the time of inspection OTEK had submitted validation samples within the excavation to the laboratory for analysis. It was decided that the excavation would remain open until these results were evaluated and submitted to the auditor for review.</p> <p>Contaminated soils identified west of Hangar 5 were chemically treated by Enviroacific Services (EPS) at the time of the inspection to stabilise mobile contaminants in accordance with EPAV Classification Approval 2009/014 (Appendix S of OTEK (2010) RAP).</p>

As discussed in Section 5.2.4, prior to removal of Hangar 5, broken asbestos was also identified at the surface near 4B/G13 (as per the borelog included in Appendix C (O TEK, 2012a) and confirmed as asbestos in laboratory testing for sample 4B/G13/0.1. Both locations (4B/G13 and 4B/VS-27/SS-1) were noted on Figure 10 of the RAP (O TEK 2011) as requiring asbestos remediation. This is further discussed in Section 5.5.1.
