31009 Riverwalk Werribee Stage 15 CLET 10042019 rev2

Nimai Hawkins
Development Victoria
Level 9, 8 Exhibition Street
Melbourne VIC 3000

Asbestos Clearance Certificate - Asbestos Remediation Works Conducted at Riverwalk Development Stage 15, Lots 1502 to 1533, Farm Road, Werribee, Victoria

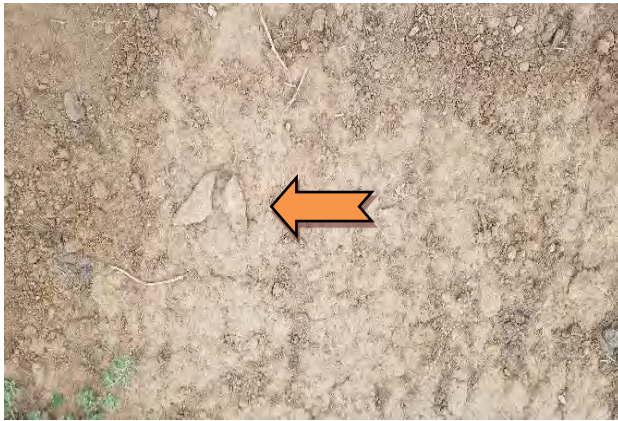
During an assessment of the Site, fifteen (15) of the thirty-two (32) Lots were identified to contain asbestos (refer to Prensa report **29856 Riverwalk Stages 15-18 Asb Inv**) (**Photograph 1**).

Photo 1. Asbestos-containing fibre cement sheet debris located on the soil surface within Riverwalk Stage 15.

- Allotments: tilling of the soil using a tractor with a chisel plough (3 m wide with tynes approximately 120 mm apart) attached, conservatively set to a maximum depth of 0.2 m. Asbestos removalists walked behind hand picking and removing visible ACM as the soil was displaced (**Photographs 2-3**). Prensa notes that the orientation of the tilling alternated based on site specific conditions (i.e. underground services, property fences etc.); and
- Nature strips: a combination of hand raking to a maximum depth of 0.1 m to remove or displace the vegetation and hand picking the visible ACM. Both of these processes were under supervision of a Prensa consultant.

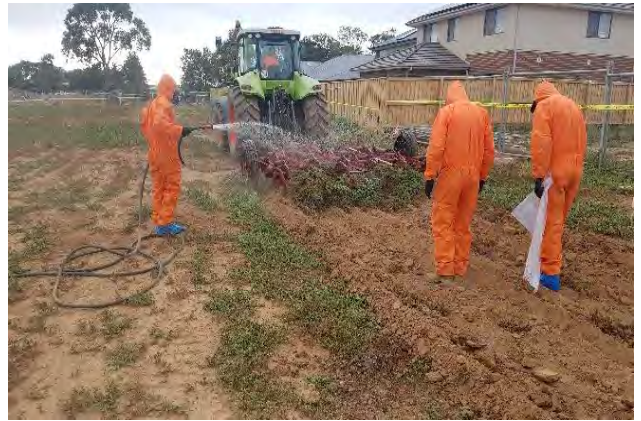
Photo 2. Riverwalk Stage 15 during remediation works.

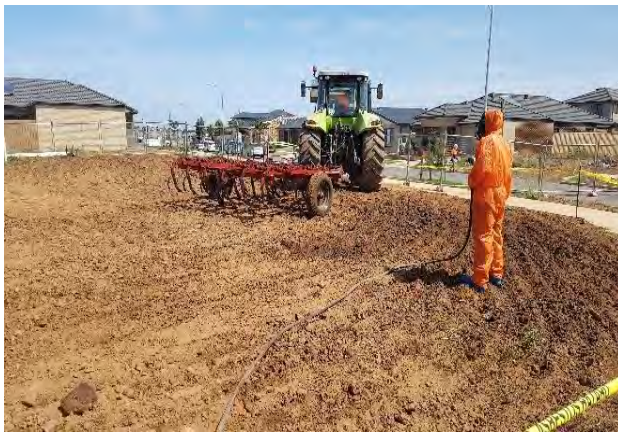
Photo 3. Riverwalk Stage 15 during remediation works

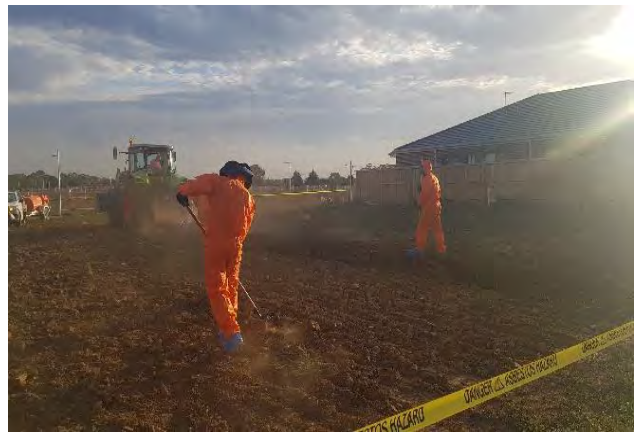
Prensa notes that additional remediation works were conducted within the vicinity of Test Pit 46 (TP46), Test Pit 44 (TP44) and Test Pit 17 (TP17) where subsurface ACM was identified during Prensa's previous asbestos investigation. This consisted of additional tilling and hand raking to remove visible asbestos containing material, from a grid approximately 10 m x 10 m within the vicinity of the test pits (**Photograph 4**).

Photo 4. Test pit remediation of Lot 1513, TP46, Lot 1514, TP44 and Lot 1526, TP17

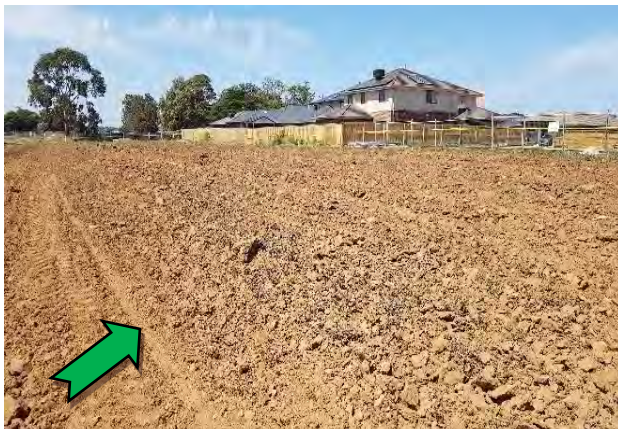
A Prensa consultant progressively inspected the Work Area from the 28th of February 2019 to the 10th of April and observed the asbestos remediation works had been satisfactorily completed, and no visible asbestos debris associated with the above listed remediation works remained on the soil surface within the Work Area where the asbestos remediation work was performed (**Photographs 5 - 6**).

Photo 5. Riverwalk Stage 15 following remediation works.

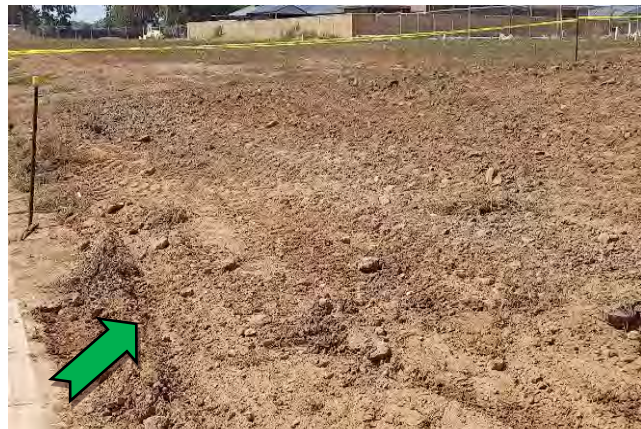
Photo 6. Riverwalk Stage 15 following remediation works
